**Marsden Park
Developments Pty Ltd**

Preliminary Report for Marsden
Park Industrial Precinct
Geotechnical Assessment

May 2009

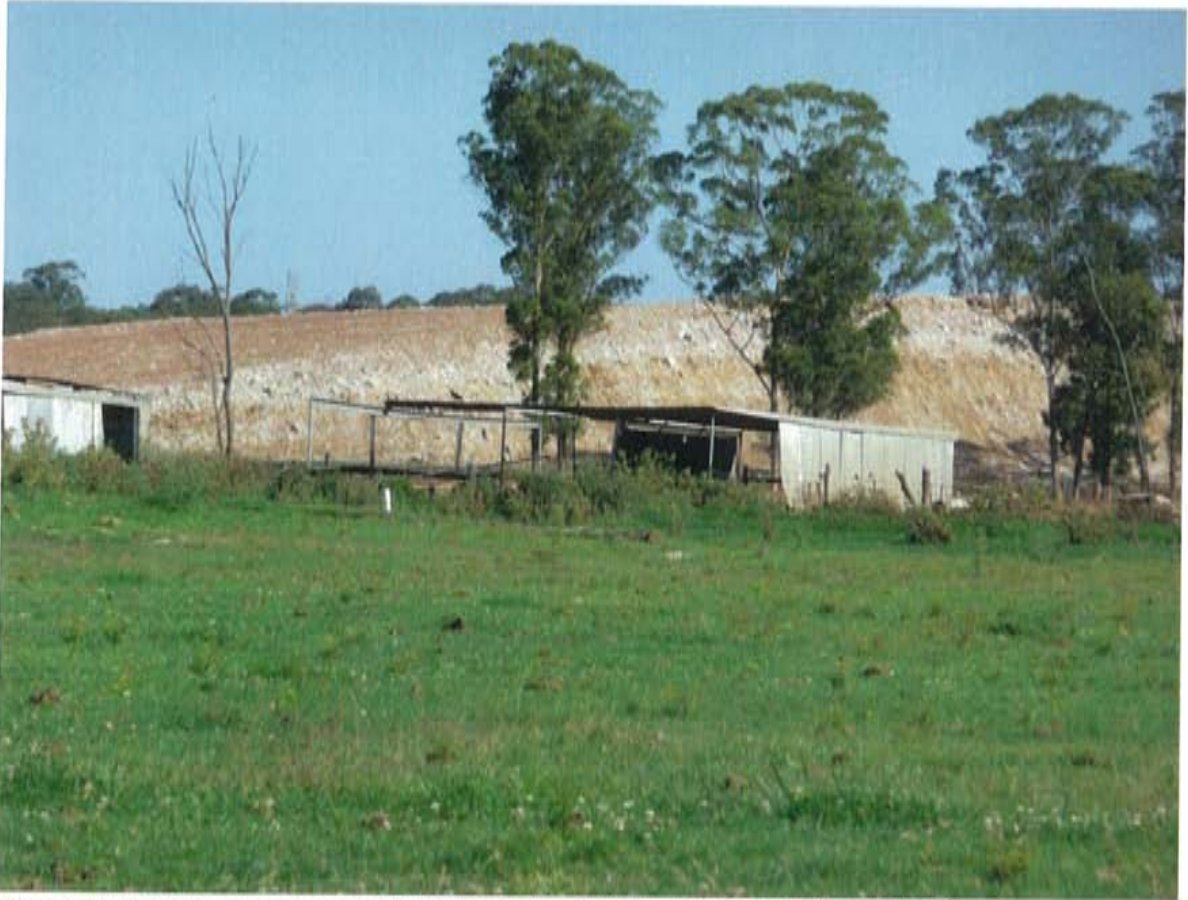
- ▶ Stockpiles of excavated material were observed to the north-west of the quarry. Refer P3.
- ▶ The dispersive nature of the site soils was evident from observed erosion gullies and dispersed clay areas such as seen in P4 in the lower landscape.

P 3 Stockpile of excavated material (predominantly clay) on NW corner of the quarry/landfill (GD5).

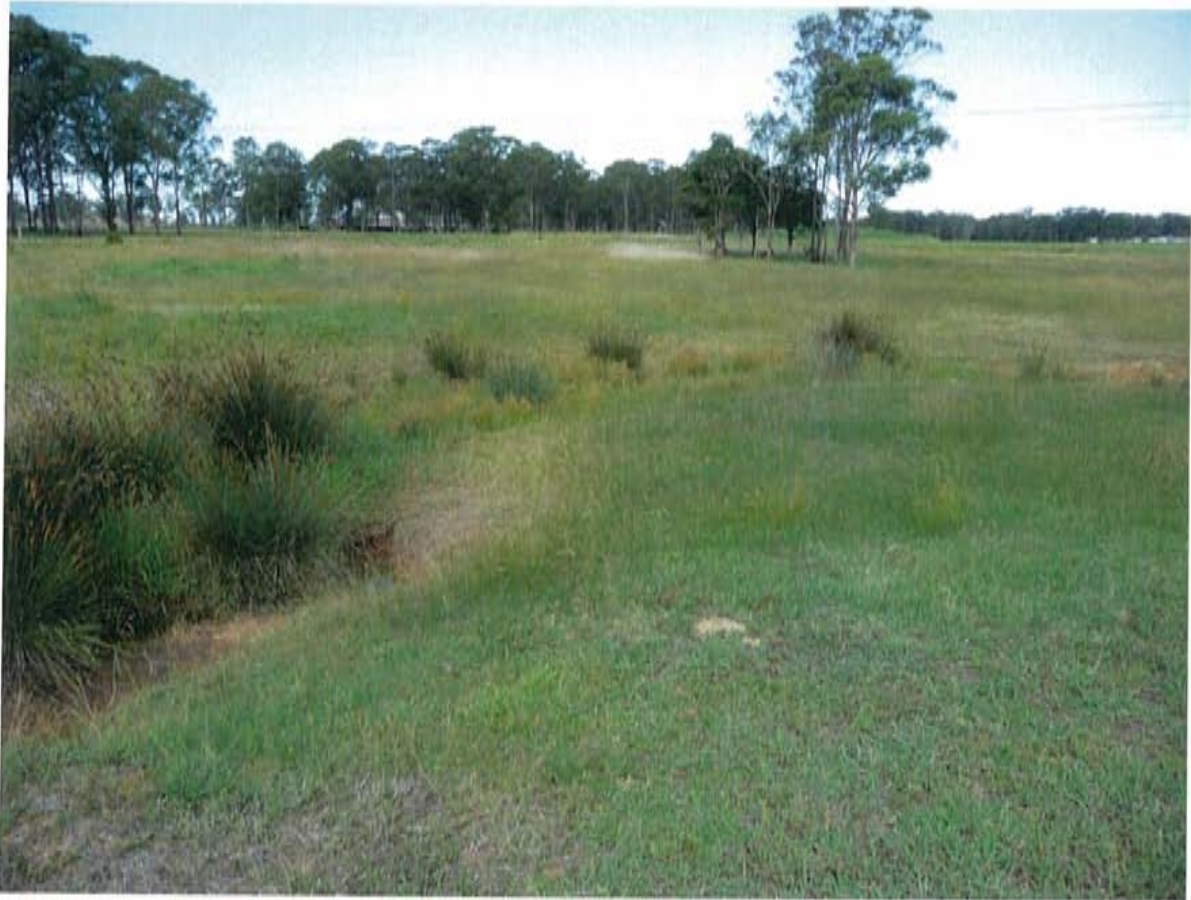
- ▶ Areas of localised filling were reported in the Phase 2 Contamination report, as well as filling greater than 2.5m thick in the SWF. P4 provides a view over the SWF from the west.

P4 Dispersive erosion on creek line, Fill area (GD5a) in background.

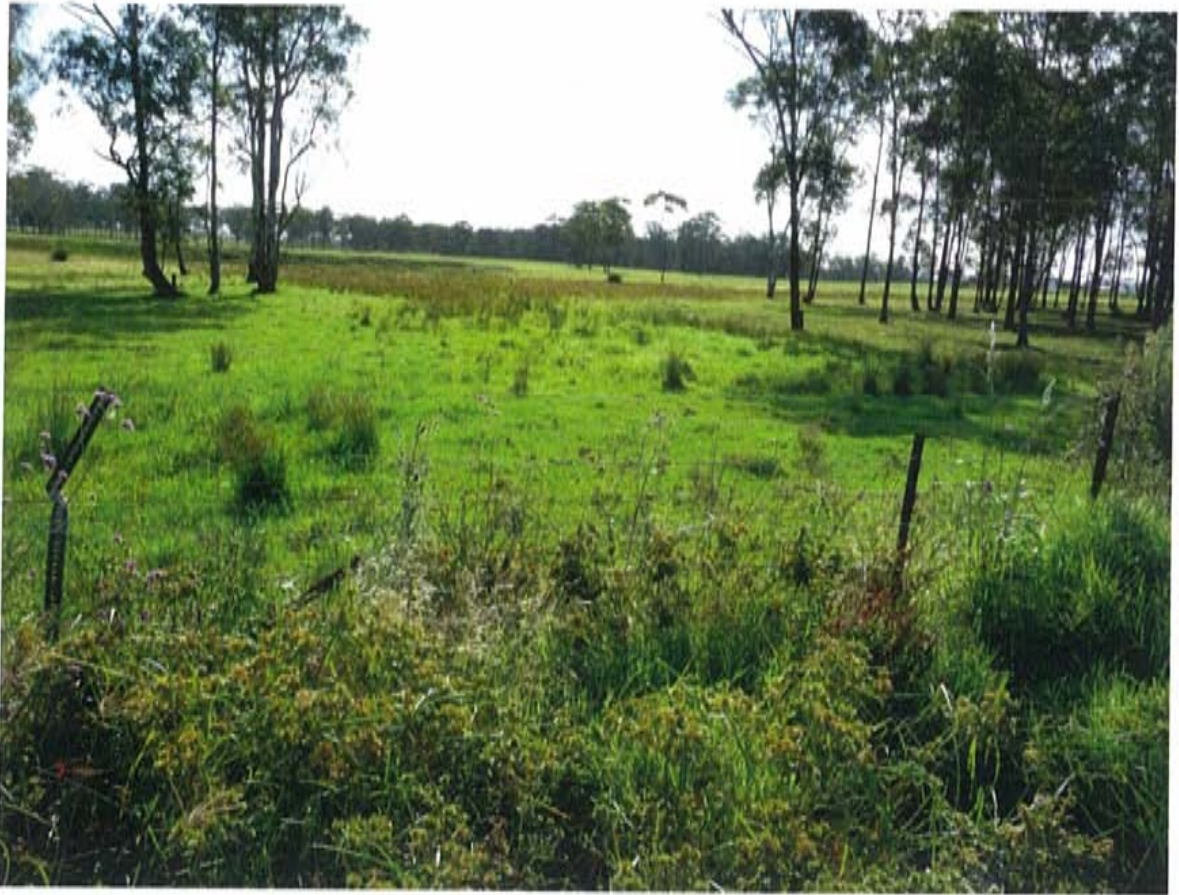
- ▶ Wetter zones were noted downstream of a number of dams. Such zones are typically the result of seepage/elevated groundwater within the lower landscape, which is elevated by the presence of the dam. Refer P5. Typically in dispersive clay environments, such as indicated for much of the site area, such seepage can lead to dispersive erosion (piping) failure.

P 5 Lower landscape east of Quarry and west of Richmond Road. Waterlogged ground below dam

It is noted that there are a number of existing small (farm) dams in the lower slope areas and to a lesser in the upper slopes. It is considered unlikely that those existing dams will meet current engineering design requirements, particularly with respect to protection measures against dispersive soil (piping) failure, and thus they may require removal for urban development purposes.

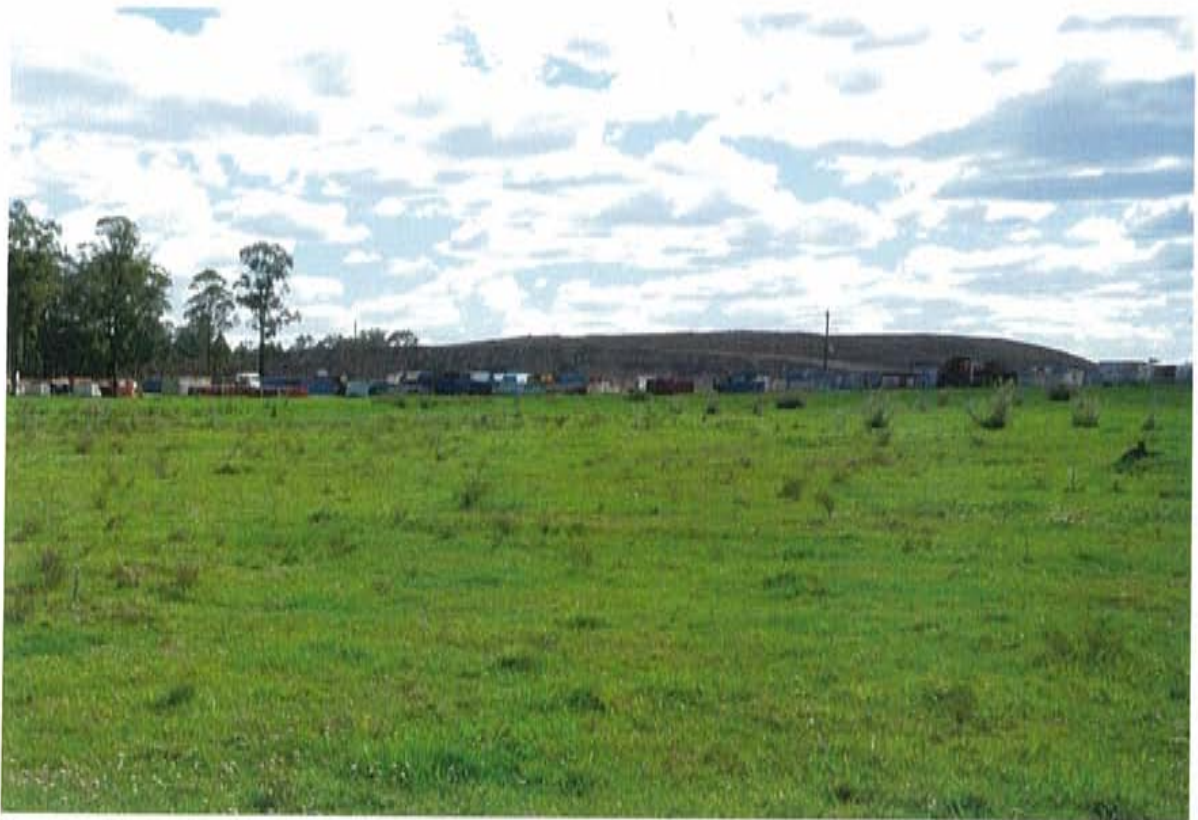
- ▶ Stockpiles of excavated material were also observed to the east of the quarry. Refer P6.
- ▶ The Minchinbury Sandstone unit was not observed as outcrop nor recorded within the Phase 2 contamination investigation borehole logs (reported under separate cover) but, if encountered within the bedrock, is expected to lead to a permeability contrast with increased seepage issues.

P6 Stockpiles of excavated material (mainly mix of clay and shale) east of the quarry/landfill area (GD5).
