**LAND CAPABILITY AND CONTAMINATION  
ASSESSMENT**

**TURNER ROAD PRECINCT**

**CATHERINE FIELD AND CURRANS HILL**

**GROWTH CENTRES COMMISSION**

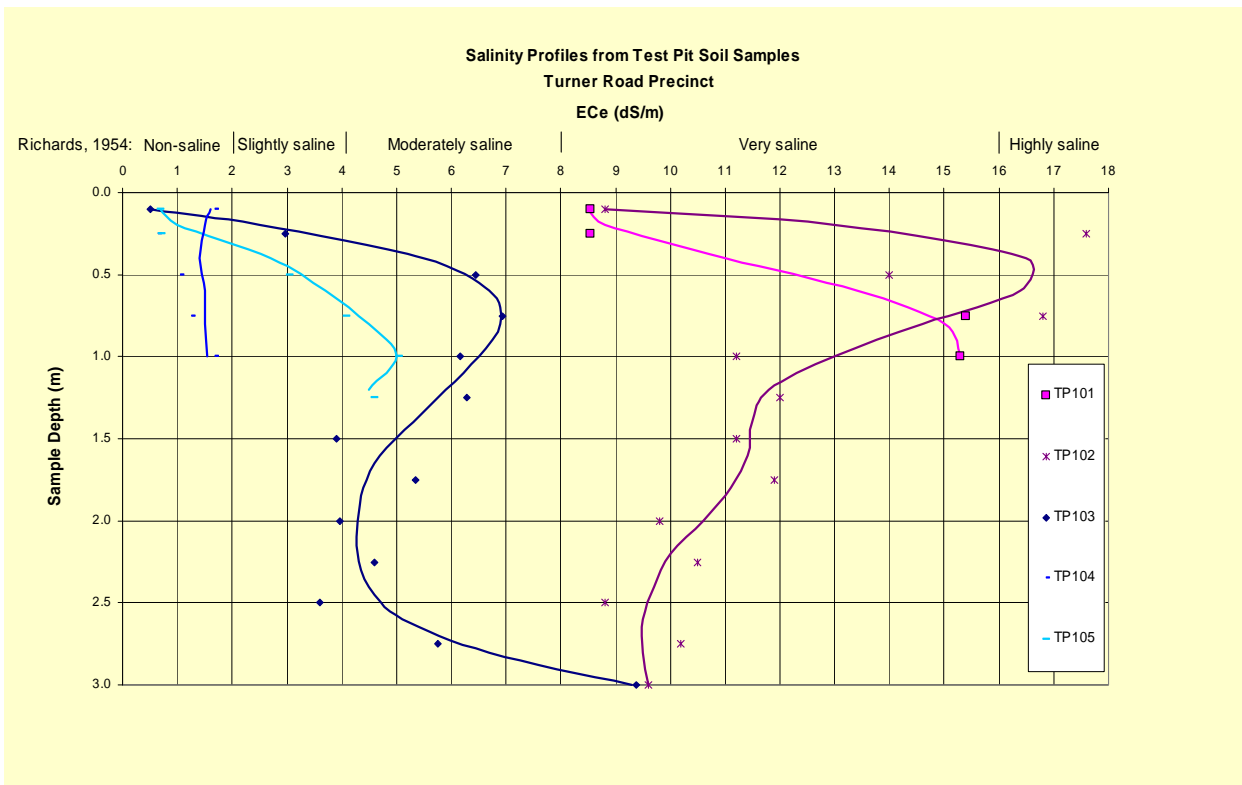
**Figure 1 – Vertical Soil Salinity Profiles**

From these profiles it is inferred that in some areas (e.g. TP 104) soils remain non-saline throughout the tested depth range. At the remaining control test pit locations, salinities generally reach maxima in the 0.5 m to 1 m depth zone, decreasing below 1 m but possibly rising again immediately above rock level. In order to assess the most saline soil horizon, follow-up test pits were sampled for salinity tests at depths of 0.5 m to 0.7 m (23 tests) and 0.9 m to 1.0 m (80 tests). In addition, salinity test results from a depth of 1 m were selected for correlation with EM results (below), since the horizon of maximum salinity (around 1 m) was inferred to have produced the bulk of the EM response.

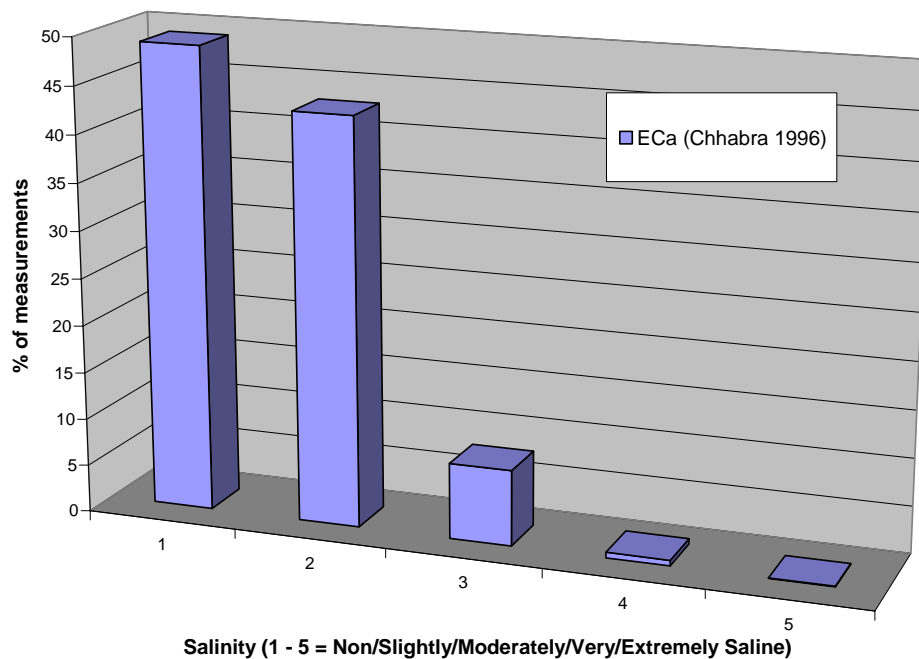
**Figure 2 – Distribution of Apparent Conductivities from EM 31 Profiling**

The histogram (Figure 2) and Table 8 below show that of the 90,500 corrected and filtered apparent conductivity measurements over the study area, 92% fall in the non-saline to slightly saline classes of Chhabra (1996, Ref 8), with <8% in the moderately saline class and <1% in the very to extremely saline classes. This represents an apparent shift towards lower salinity classes by comparison with the classifications from test pit sample salinities alone (Table 7 above), as a result of the difference in classification schemes. This highlights the need for “calibration” of the conductivity data to conform with the classification scheme of Richards (1954, Ref. 9), currently accepted by authorities such as DIPNR for use in urban salinity management.

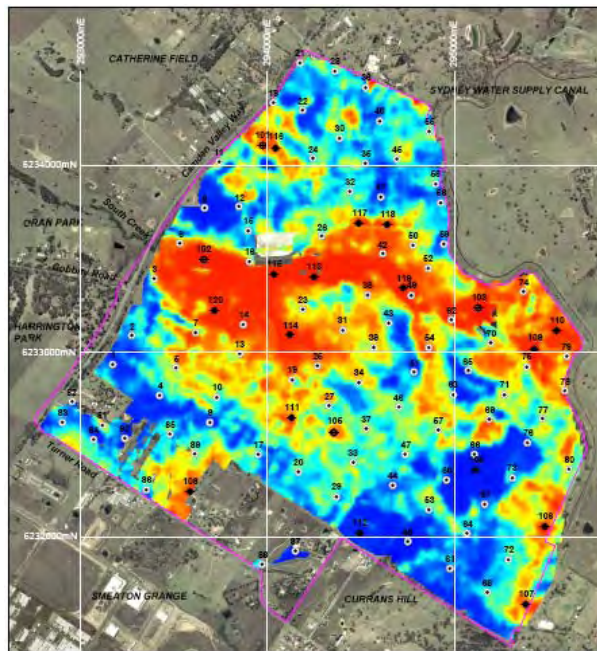
Apparent Conductivity (see Drawing 14, Appendix A)

Apparent conductivity data were added to the GIS database for interpolation onto a regular grid throughout the area surveyed. Drawing 14 (Appendix A and thumbnail image below) presents the apparent conductivity image with a continuous colour spectral scale in mS/m. Areas of most interest are those coloured bright red. Using the classifications of Chhabra (1996, Ref 8), these colours may indicate moderately saline to extremely saline ground conditions.

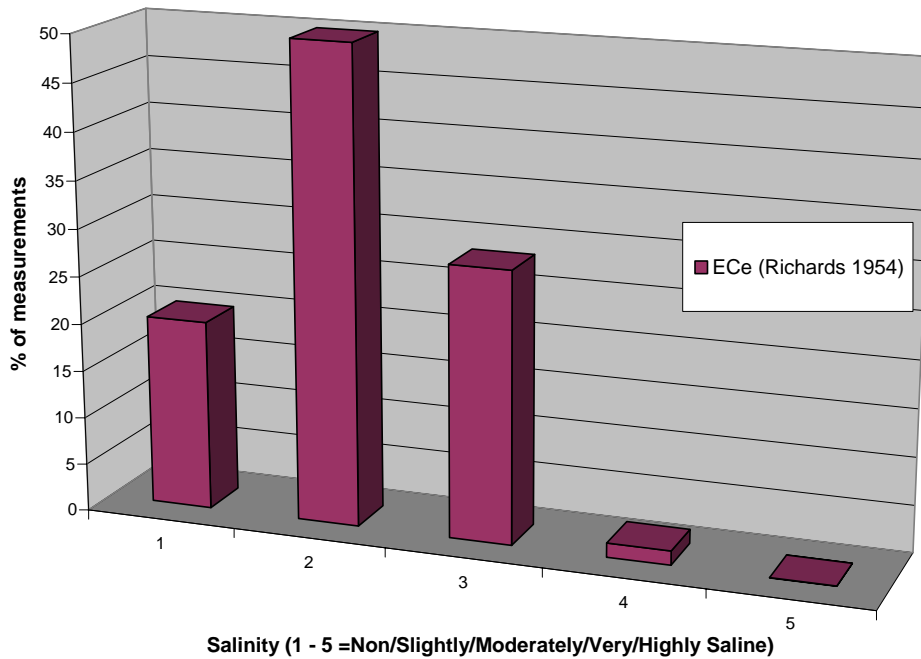
**Figure 3 – Distribution of Apparent Salinities**

To achieve a consistent classification from both test pit samples and EM profiling data, a form of calibration of the latter was carried out as described in Appendix C. A line-of-best-fit to an E<sub>Ce</sub>/E<sub>Ca</sub> scattergram provided a factor of 5.97 by which to multiply apparent conductivities (in dS/m) to estimate E<sub>Ce</sub> values throughout the EM31 data set. The histogram (Figure 3) and Table 9 below show that of the re-scaled data points, 70% fall in the non-saline to slightly saline classes of Richards (1954, Ref. 9), 28% fall in the moderately saline class and <2% fall in the very saline to highly saline classes.

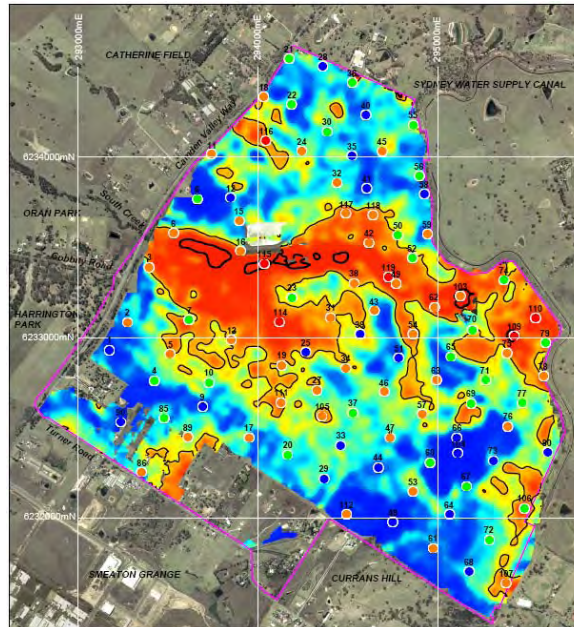
Apparent Salinity (see Drawing 15, Appendix A)

Contours were added to the image in Drawing 15, corresponding to the 4 dS/m and 8 dS/m boundaries of the salinity classes of Richards, providing a direct subdivision of the study area into non-saline and slightly saline classes (<4 dS/m), moderately saline class (4 – 8 dS/m) and very saline class (>8 dS/m). No highly saline areas were inferred.

Areas inferred to be moderately saline or very saline generally occur along the South Creek drainage system but extend into low lying drainage areas and around dams within the golf course north of South Creek and to some areas south of South Creek and close to Turner Road.

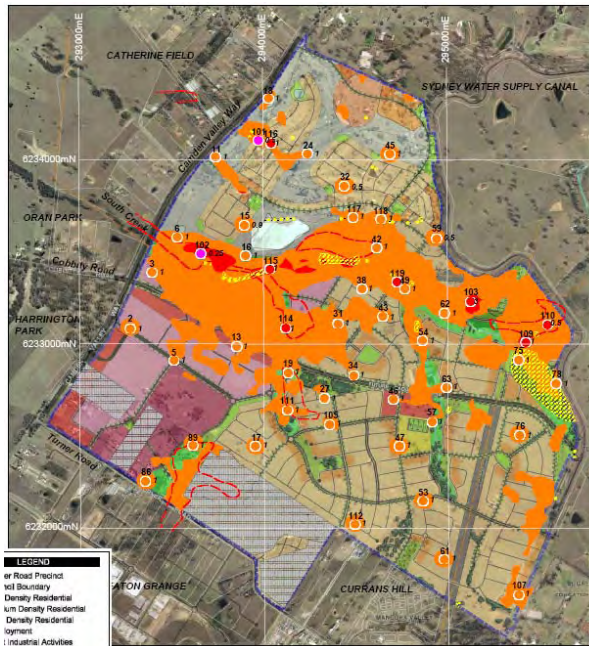
Salinity Constraints (see Appendix A, Drawing 16)

To better assess the constraints that saline soils may place on the proposed development, a number of mappable features were overlain on the aerial photograph of the site to produce a Salinity Constraints map (Drawing 16 Appendix A and thumbnail image below).

- To manage soil from specific building sites or services alignments within the moderate salinity constraint regions or moderate aggressivity constraint regions of Drawings 16 and 18 (Appendix A), use of a bedding layer of sand (say 100 mm minimum) followed by a membrane of thick plastic is recommended under concrete slabs to act as a moisture barrier and drainage layer to restrict capillary rise under the slab.

- Higher than normal strength concrete (say 32MPa) or sulphate resistant cement may need to be considered in very saline constraint regions in order to reduce the risk of reinforcement corrosion in concrete slabs. A minimum of 65 mm of concrete cover on slab reinforcement, proper compaction and curing of concrete are also suggested to produce a dense low permeability concrete.

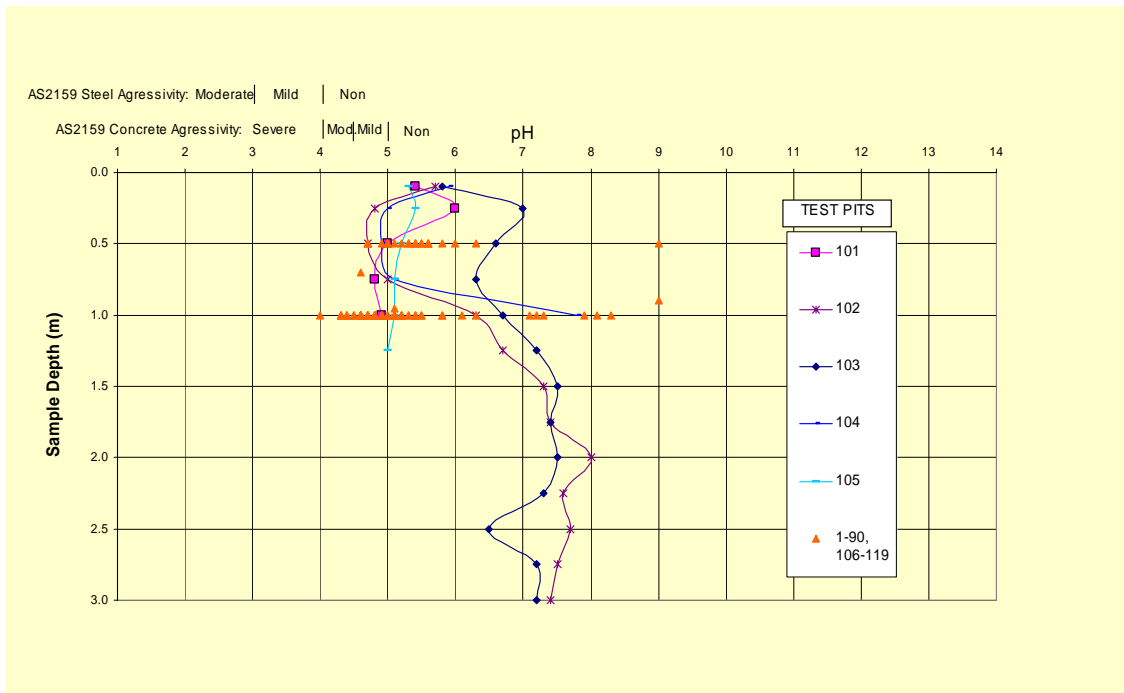
**Figure 4 – pH Profiles**

Aggressivity to concrete varied from non-aggressive to moderately aggressive as indicated by the pH profiles and scattergram of Figure 4, with a tendency for greatest aggressivity in the 0.25 m to 1.0 m depth range.

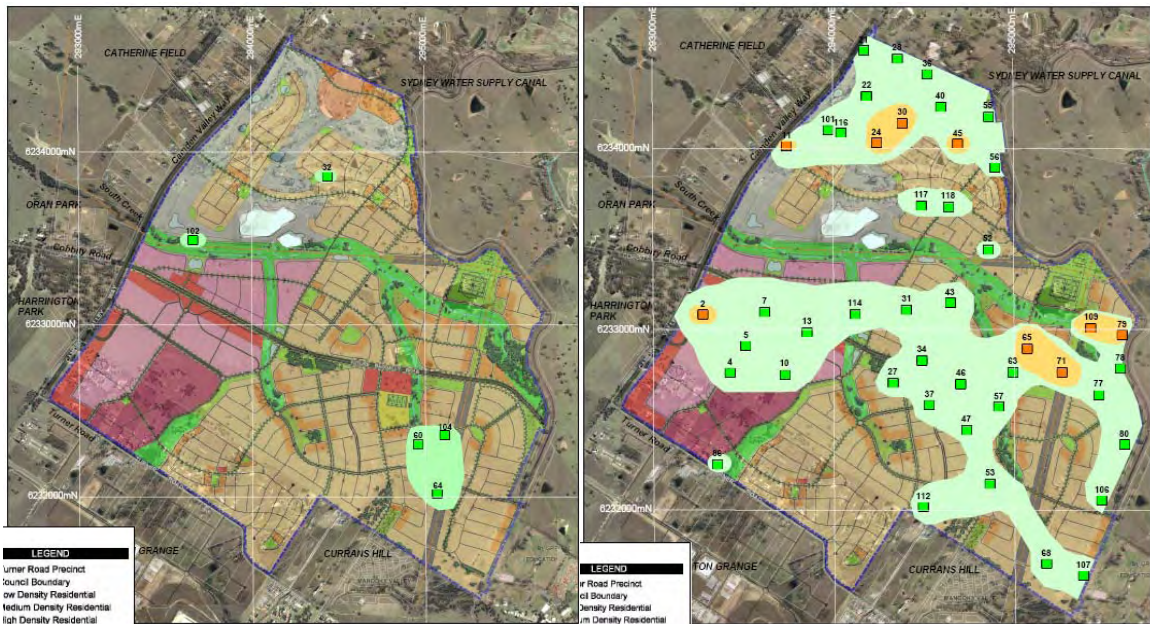
L & R: Aggressivity to concrete at 0.5m and 1m depths (See Drawings 17 and 18, Appendix A)

Drawings 17 and 18 (Appendix A and thumbnail images below) show the lateral distributions of aggressivity to concrete at depths of 0.5 m and 1 m respectively. Because of the number and widespread distribution of test pits from which aggressivity classifications were made, approximate boundaries of mildly aggressive and moderately aggressive zones could not be inferred, so that these drawings do not represent aggressivity constraint maps (discussed in 12.3.4 below).

It should be noted that the soils within the lower slopes around South Creek are characterised by moderately saline to highly saline soil but are inferred to be non-aggressive to concrete, possibly due to lithological differences in the vicinity of South Creek.

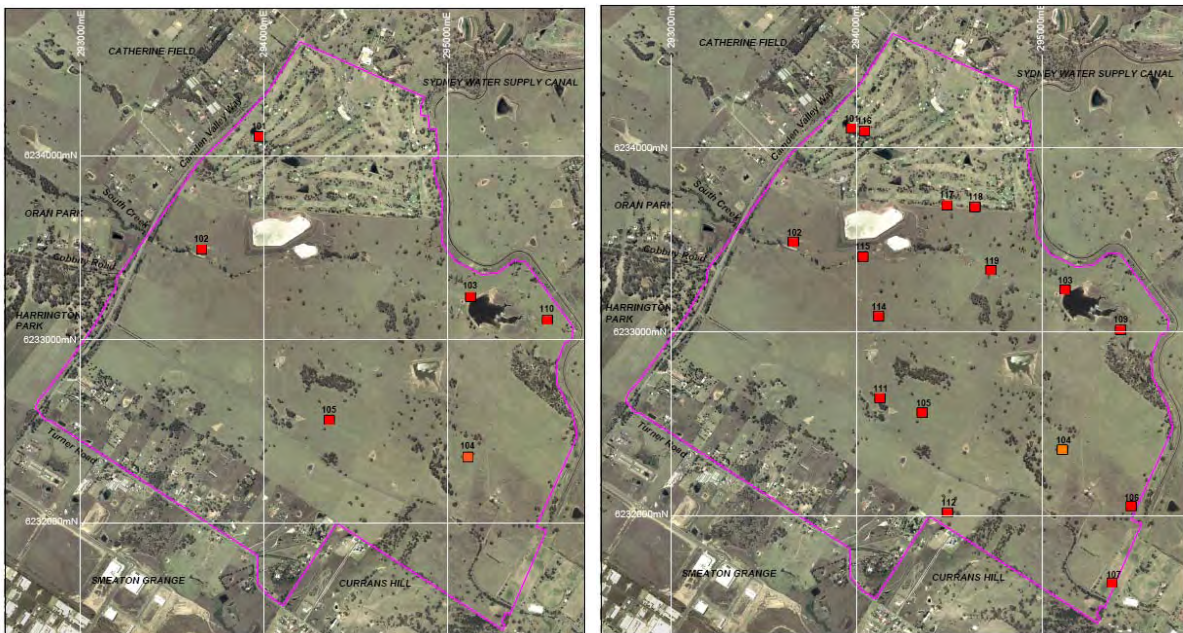
L & R: Sodicity at 0.5m and 1m depths (See Drawings 19 and 20, Appendix A)

Laboratory results and classifications are presented in Table 7a (Appendix J) and indicate highly sodict conditions at both depths in all but one tested location. At Test Pit 104, sodict conditions were indicated at both depths.

Drawings 19 and 20 (Appendix A and thumbnail images below) show the lateral distributions of sodicity at depths of 0.5 m and 1 m respectively. The relatively small number and sparse distribution of test pits from which sodicity measurements were made, prevents the interpretation of detailed sodicity constraint zones. However on the basis of these measurements, it is considered likely that sodic to highly sodic conditions exist throughout the Precinct and that salinity management plans should include strategies for management of this associated property.
