Marsden Park Precinct

Historic Heritage Assessment

For Winten Property Group

March 2013

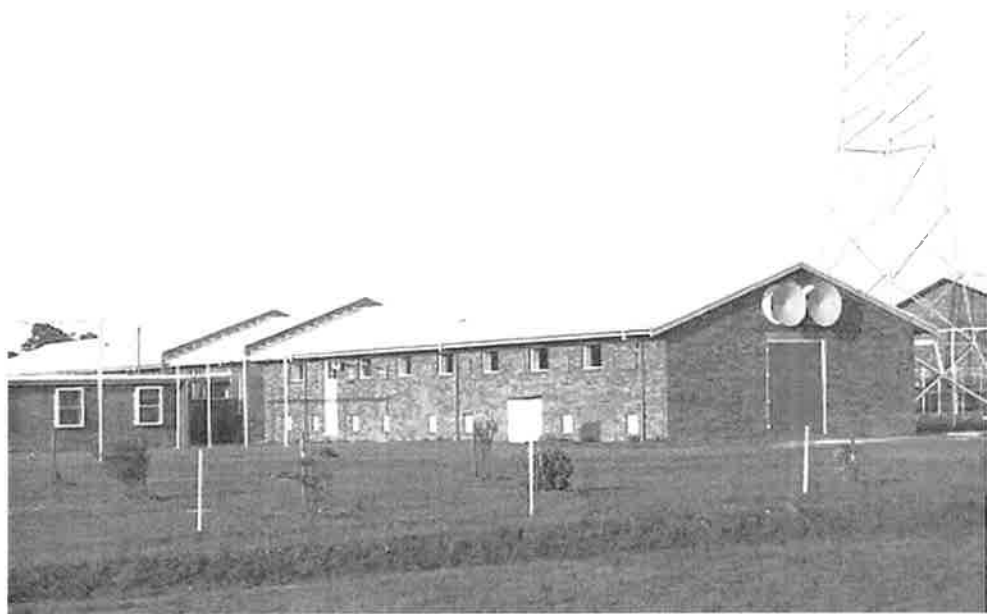
Figure 3.8 Photo from 1963 showing HF Transmitter Station (CAHS Collection).

At the centre of the facility was a main transmission building which housed a series of rooms including an equipment room, workshop, store and air-conditioning plant. The buildings were constructed from brick with a roof comprised of steel trusses with a corrugated asbestos cement sheet roof and concrete foundations with numerous cable runs in the concrete slab (Parsons 1960).

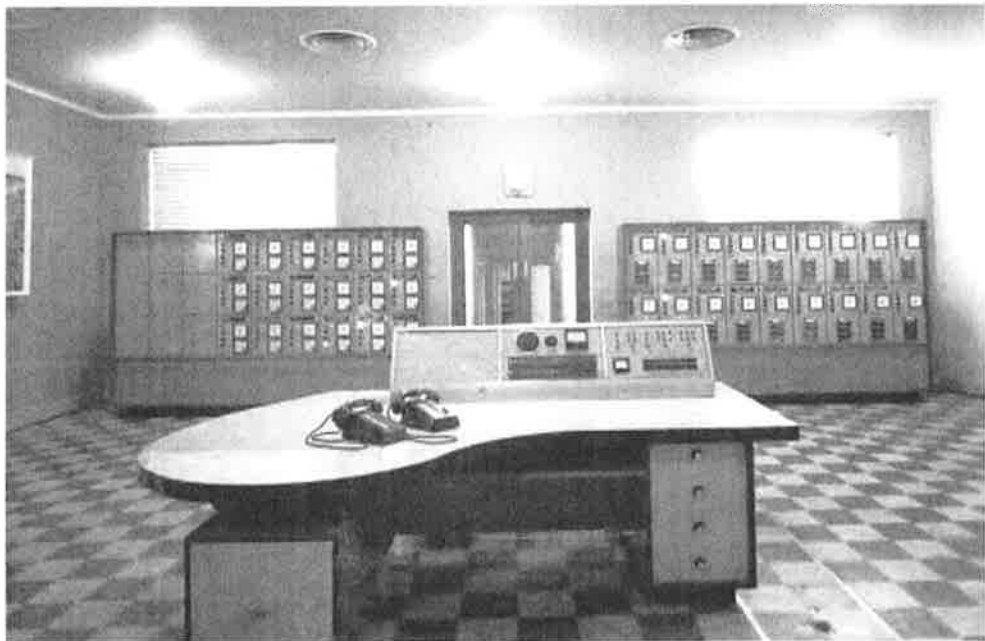
Figure 3.9 Photo from 1963 showing the Llandilo HF Transmitter station control room (CAHS Collection).

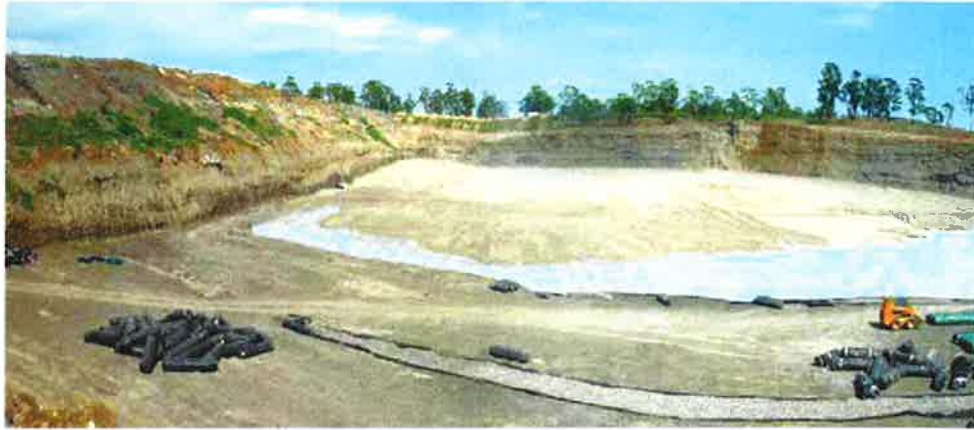
Figure 3.18 *The gravel and clay quarry at Marsden Park during preparations for use as a landfill site c1998-2000 (<http://www.polyfabrics.com.au/>)*

An area south of Marsden Park, within the Marsden Park Industrial Precinct, has been used as a gravel (crushed breccia) quarry for road base and a clay shale quarry for brick-making (see *Figure 3.18*). The quarry operated from the mid 1960s until c2000, with onsite crushing machines. Much of this former quarry site has since been used as a landfill site for industrial and commercial dumping. The surrounding land is dominated by market gardens and poultry farming, including a distribution site for Steggles.

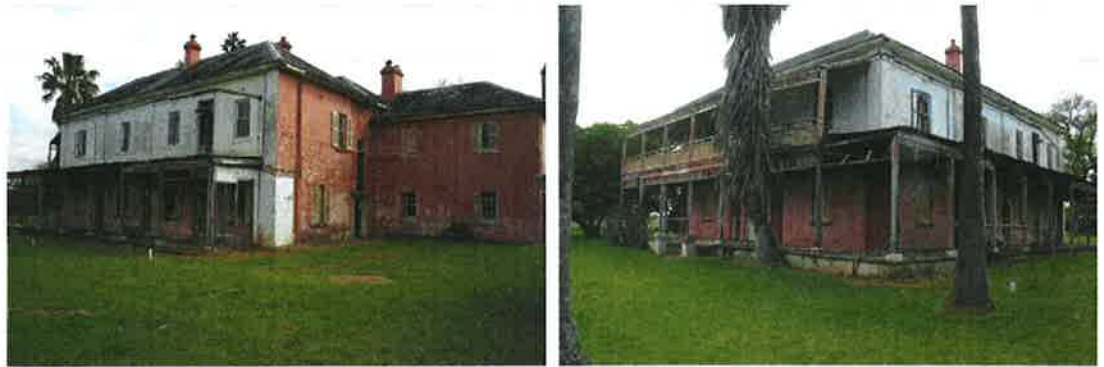
Figure 4.2 View of Clydesdale house looking north (left) and view of south east elevations with original palm trees in the forefront (right)

The field survey identified Clydesdale as a brick building with a square floor plan with an extension to its south-east elevation (*Figure 4.2*). Few structural changes have been made to the house since the 1880s when it is believed the second storey verandah was added by the Mayor of Sydney, John Hardie (*Figure 4.2*).

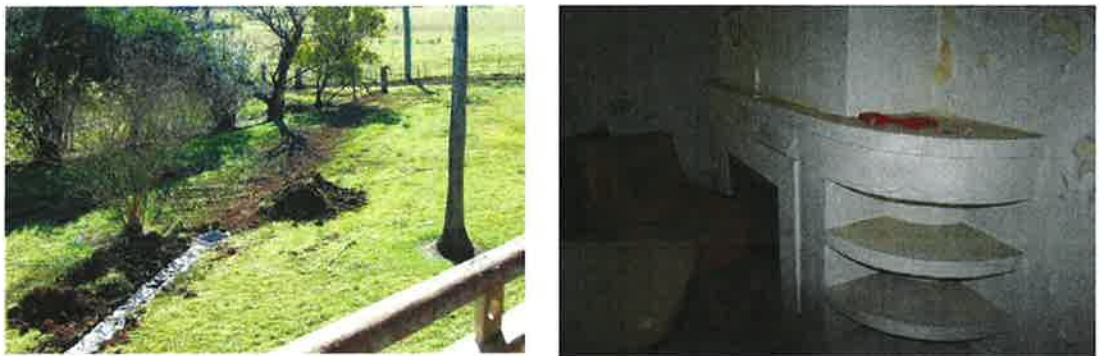
Figure 4.3 View of remedial drainage works (Heritech Consulting 2009) (left) and detail of fireplace with water damage to wallpaper (right)

Water damage to the ground level of the house was identified during the field survey by the separation of wall paper from a wall (see *Figure 4.3*). Two areas of missing floorboards from termite damage were also noted in a corner of one of the ground level rooms.

Stabilisation works such as the beams and columns supporting the verandah were identified and attributed to the remedial drainage works carried out in 2009 by Heritech Consulting. During these works further structural works were carried out including the temporary removal of the rear staircase and portico, removal of the 1940's bathroom, installation of the remedial drainage to prevent flooding and pooling of water in the southern corner of the house, the strengthening of beams and columns supporting the SW verandah and the temporary covering of the upper SW verandah with galvanised steel sheeting (see *Figure 4.3*) (Heritech Consulting 2009:5).

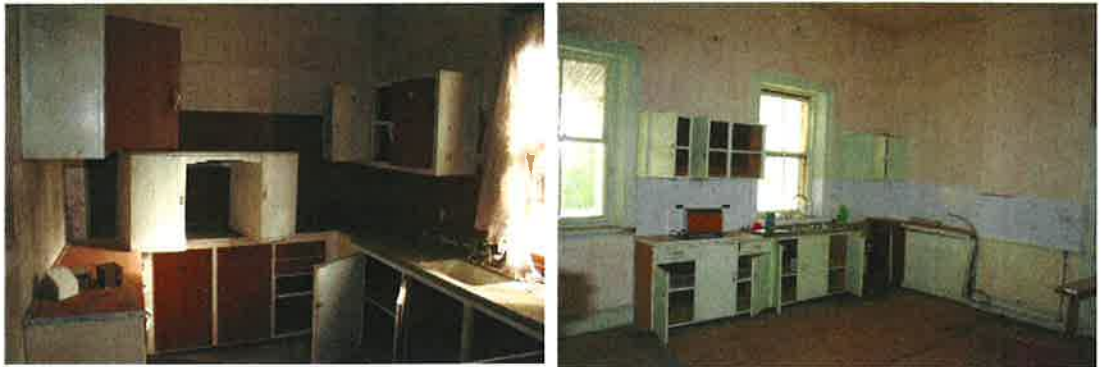
Figure 4.4 View of downstairs kitchen (left) and view of upstairs kitchen (right)

Mid to late 19th century fittings were identified in the upstairs and ground level kitchens (see *Figure 4.4*). *Figure 4.6* shows the detail of the original oven identified in the ground floor kitchen.

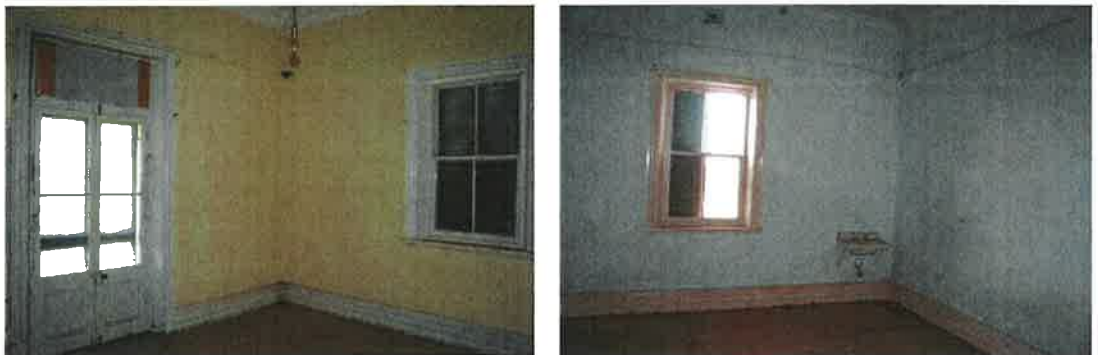
Figure 4.5 View of Upstairs rooms. Note the sink fitting in the corner of the figure on the right

During WWII the house was used as a hospital and *Figure 4.5* shows a sink fitting in an upstairs room from this time. A later addition of a dividing wall was also noted between two of the rooms upstairs. The larger room may have initially been used as a hall or living space, and may have been converted during the buildings use as a hospital or later living quarters.

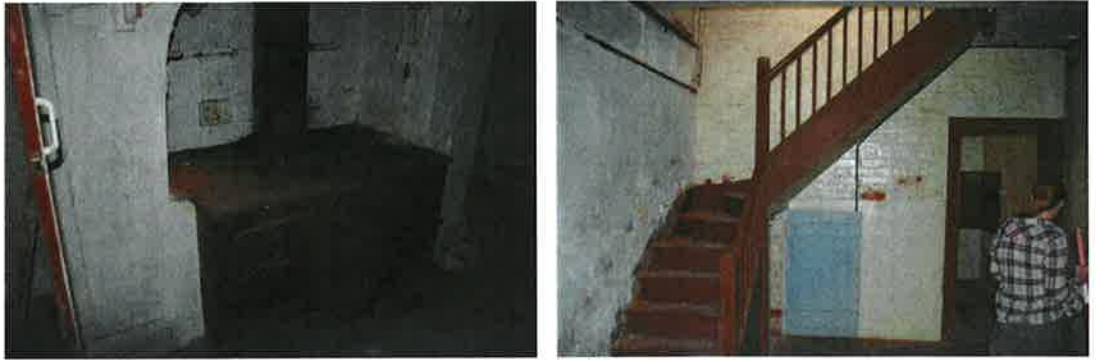
Figure 4.6 *Detail of original oven (left) and a view of a downstairs stairwell (right)*

An early 19th century oven was identified during the field survey and is shown in *Figure 4.6*.

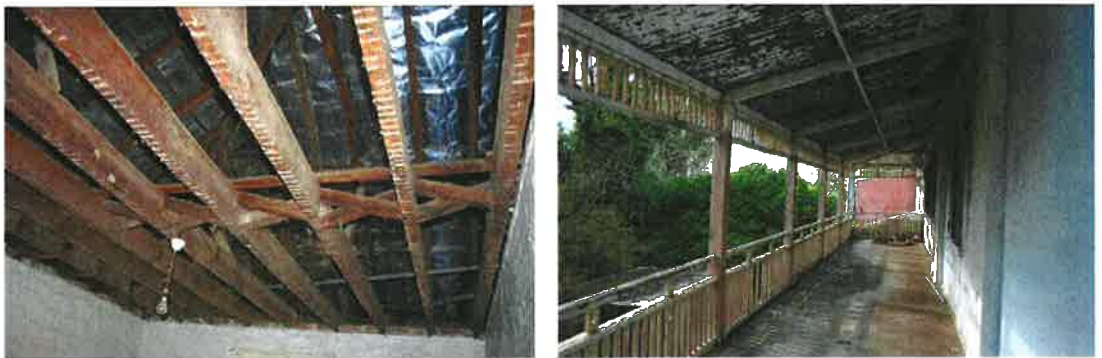
Figure 4.7 *Detail of ceiling from second level (right) and view of upstairs verandah (right)*

Figure 4.7 shows the internal structure of the roof with supporting beams from the second level of the house. The upstairs verandah is shown in the image on the right in *Figure 4.7* and is attributed to the later 19th century during John Hardie's occupancy of the house.

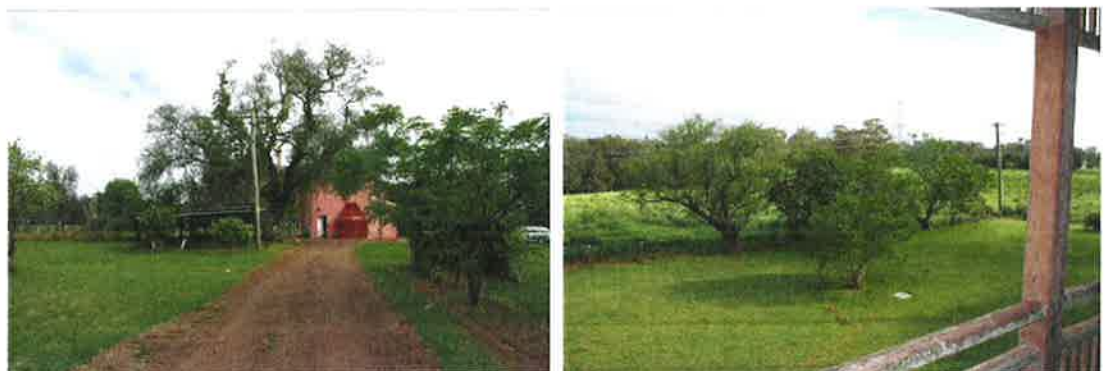
Figure 4.8 *View of Clydesdale house from farmer's cottages looking north and (left) and the view looking north from the upstairs verandah (right)*

Figure 4.8 (left) shows the view of the house from the Farmers cottages looking north. Figure 4.8 (right) shows the view looking north from the upstairs verandah to the right. These photographs show that the current curtilage protecting Clydesdale house has retained the rural open space character appropriate for a rural homestead.

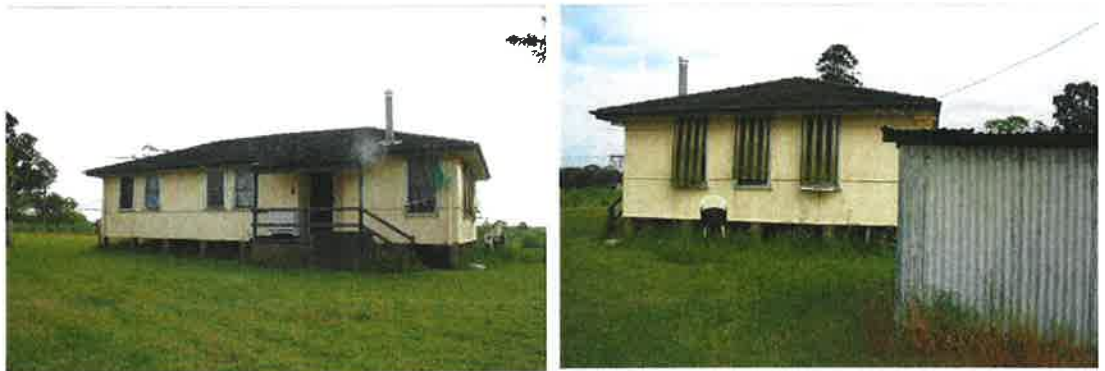
Figure 4.9 *View of the south-western facing entrance (left) and the south-east façade (right) of a farmer's cottage*

The first house dates from the 1940s or 1950s and is clad in asbestos cement sheeting with a tiled roof, wooden window sills, a south-west facing entrance, a rectangular structure with east-west alignment and set on brick foundations (Figure 4.9).

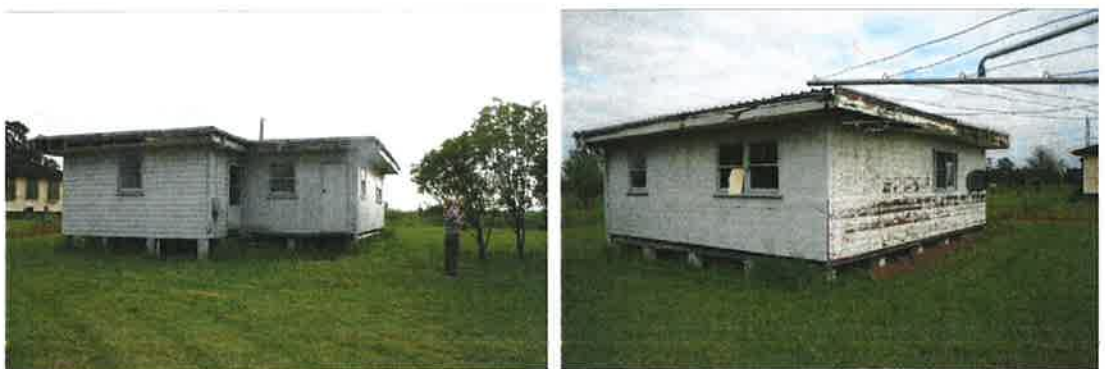
Figure 4.10 *View south-west facade of a farmer's cottage with entrance (left) and view of the rear (right)*

Figure 4.10 shows a weatherboard house with a flat, corrugated iron roof, set on brick-column foundations.

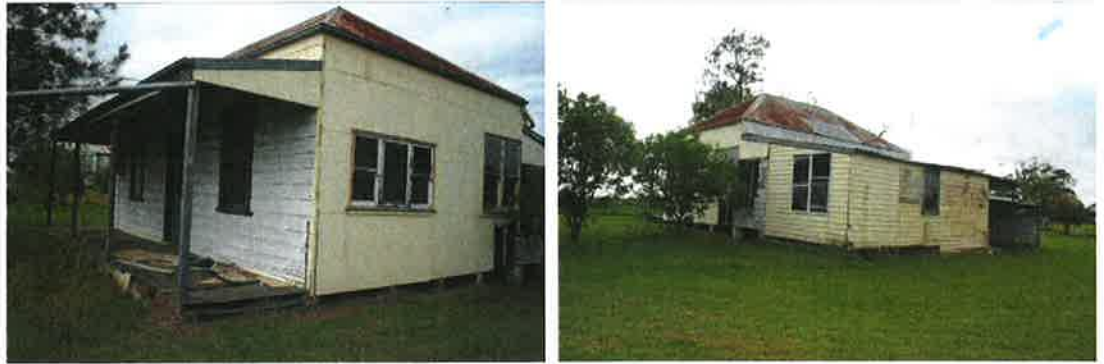
Figure 4.11 View looking south-west (left) and view of house looking east (right)

Figure 4.11 shows an early 20th century rectangular weatherboard house with a west facing front door, wooden windowsills, a hipped galvanised iron roof, asbestos cement clad walls on the northern façade with a verandah and set on brick foundations. A later skillion roofed extension is located on the southern façade.

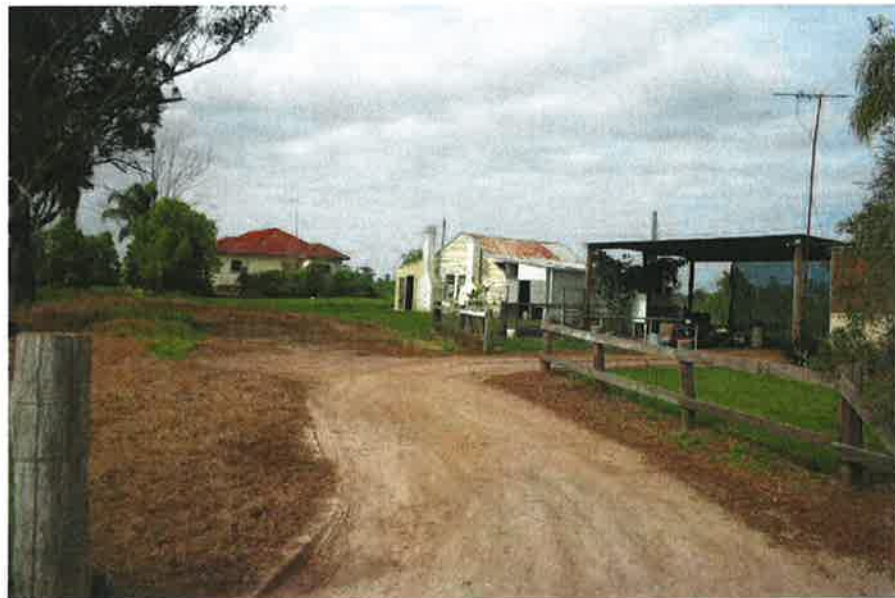
Figure 4.12 Farmer's cottage

The late 19th century timber cottage shown in the foreground of *Figure 4.12* is lined externally in weatherboard with a galvanised iron clad gable roof, twin brick chimneys on the eastern façade end and a front verandah on the northern elevation. The building is in a poor physical condition.

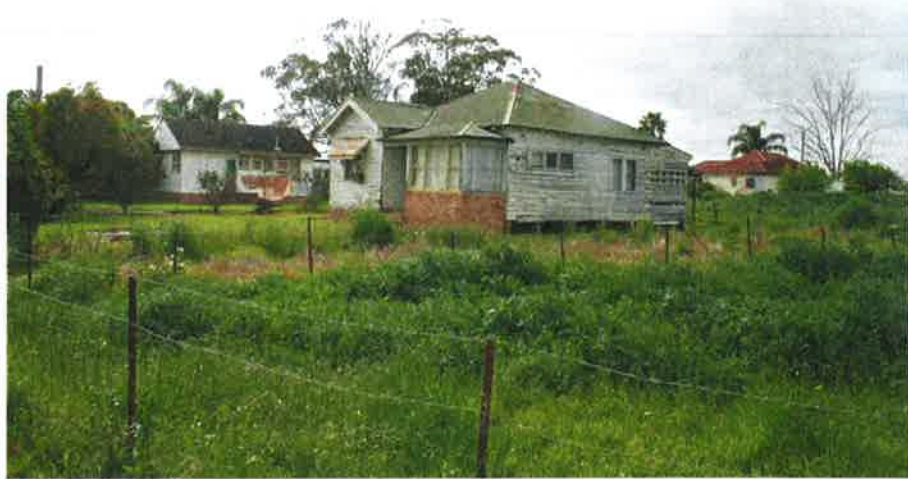
Figure 4.13 Farmer's Cottage

Figure 4.13 is a square weatherboard early 20th century house with a bay window at the front with enclosed verandah and a corrugated iron roof. It has wooden fittings and brick foundations.

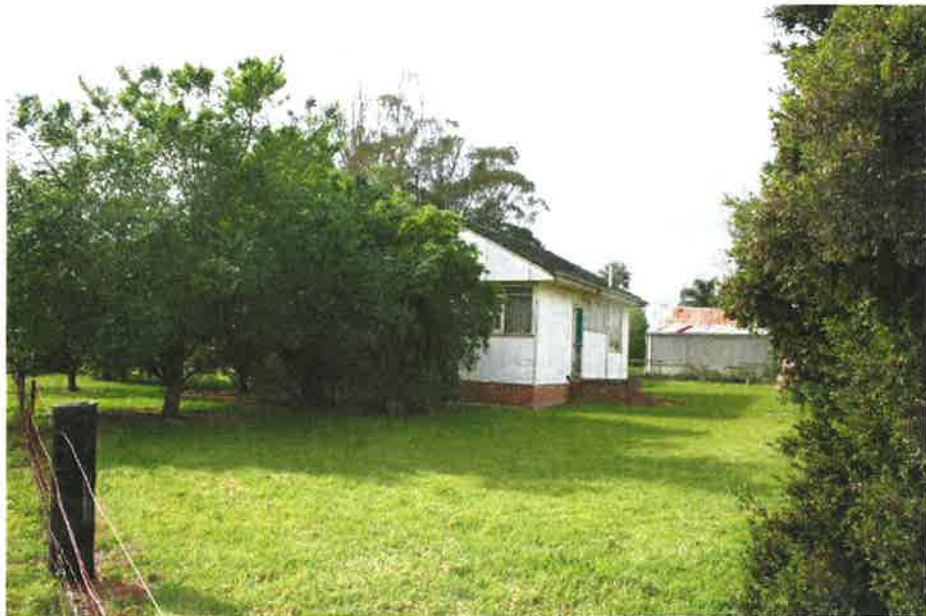
Figure 4.14 Farmers cottage

Figure 4.14 is a mid-20th century weatherboard house with wooden window sills and door fittings, a corrugated iron roof with a front gable. It is approximately 10 by 15m².

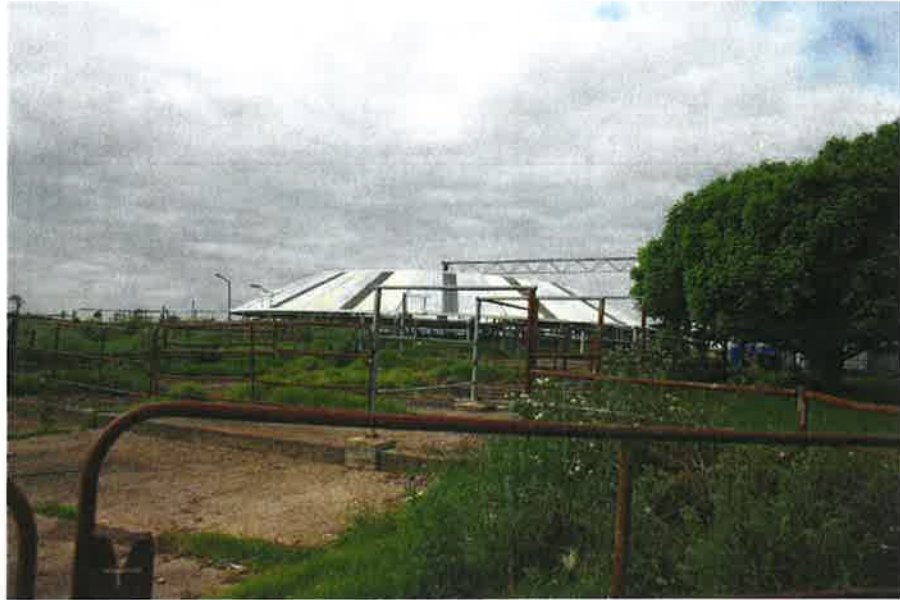
Figure 4.15 View of the Rotary Dairy

The Rotary Dairy was constructed by Associated Dairies Pty Ltd that has owned the Clydesdale property since 1963 (*Figure 4.15*). The rotary dairy operates by having cows enter as the turntable is moved in a circular direction with enough time for the cows to be milked completely. Public access is limited to the dairy therefore the structure could not be inspected in more detail. The dairy originally functioned on hydrological power which was a highly innovative technological feature during the mid-19th century. The structure appeared to be in moderate physical condition and is still used today running on electrical power.

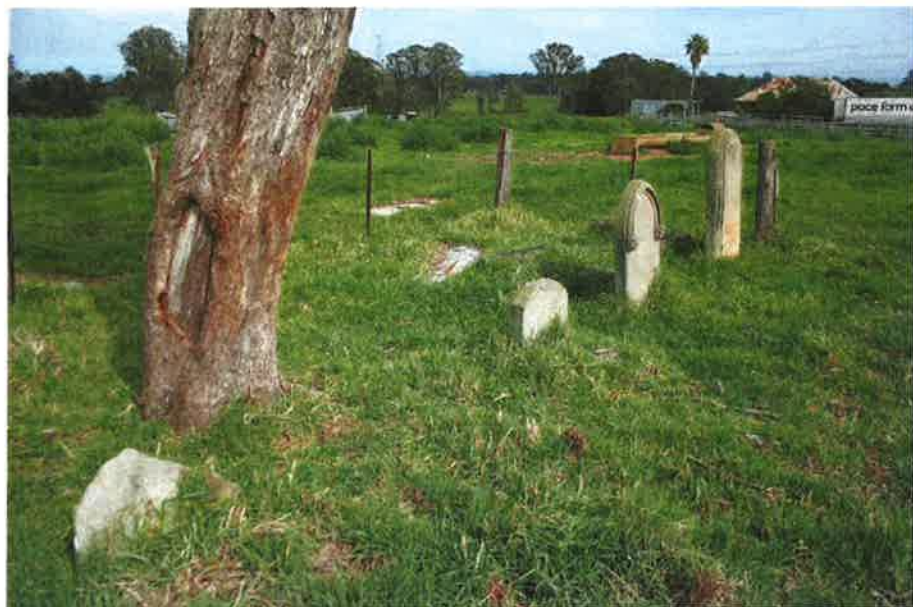
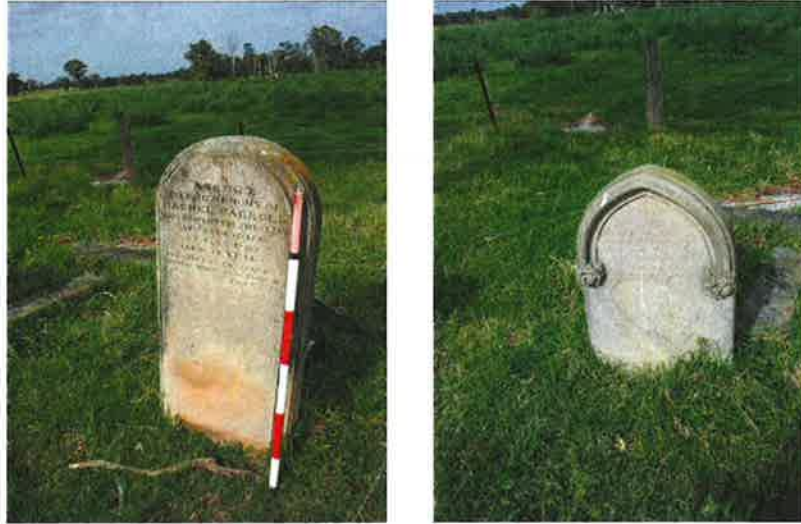
Figure 4.16 View of Clydesdale cemetery looking north-west

Figure 4.17 *Detail of grave markings*

The field survey re-identified the family cemetery located to the south of the Clydesdale homestead (see *Figure 4.16*). Four grave markings were identified; the details of two grave markings are shown in *Figure 4.17*.

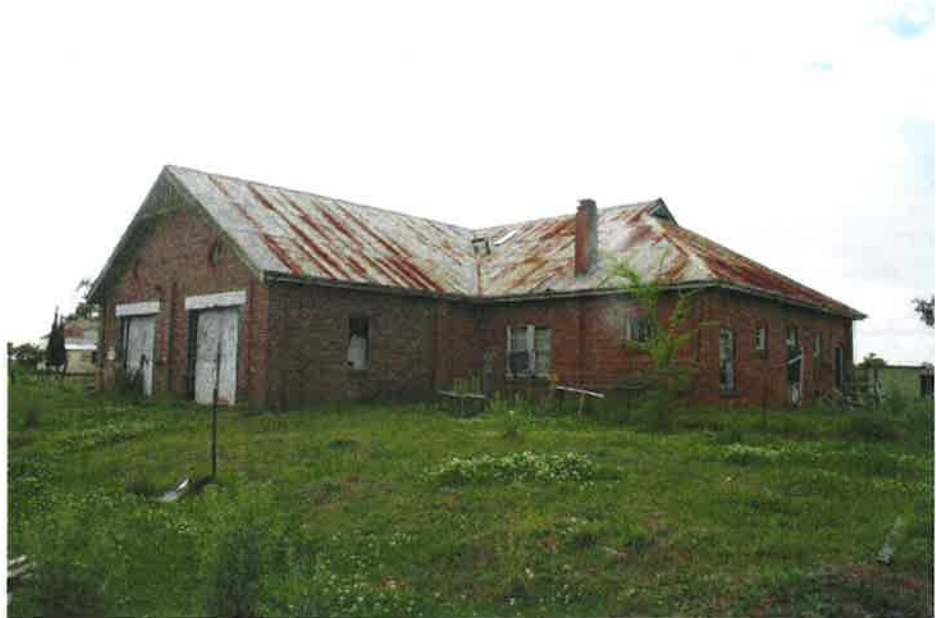
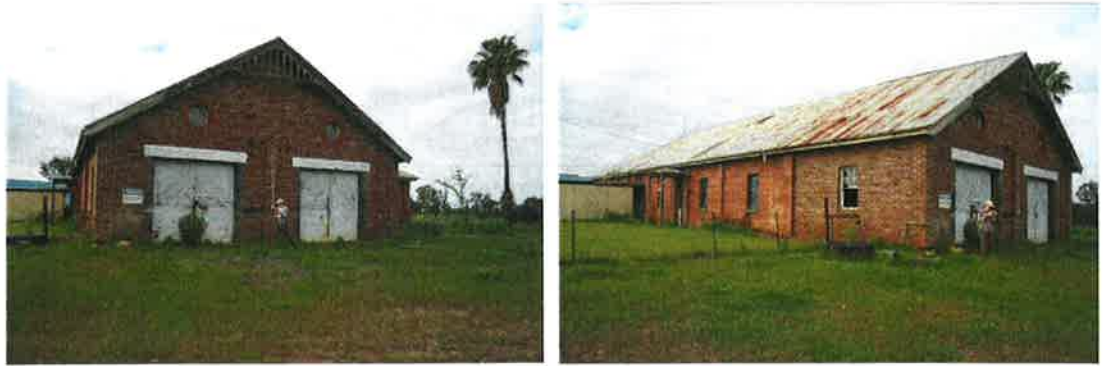
Figure 4.18 *View of Clydesdale barn looking south-east*

Figure 4.19 *View of Clydesdale barn looking south (left) and looking south-west (right)*

This field survey identified the Clydesdale barn referred to in SHR Clydesdale Estate citation and is located to the south of the house itself. The barn is a ‘T’ shaped brick structure with a galvanised iron gable roof, and a single brick chimney (*Figure 4.18*). The barn has an earth floor. The timber windows are double hung and the doors are also constructed in timber. There are two large timber doors on the barn’s south-west façade that show evidence of driveways leading onto the main access road. The surface of these areas has sparse to no grass compared to the surrounding area. There are two circular windows above these doors (*Figure 4.19*).

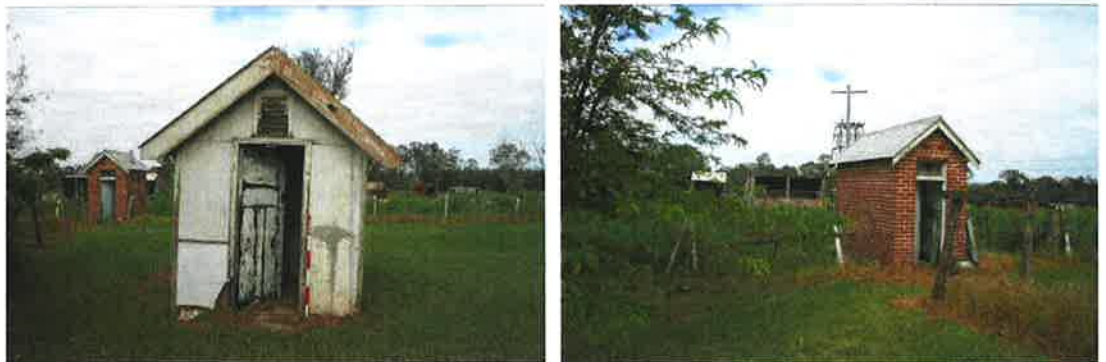
Figure 4.20 *View of two privies located south of Clydesdale house(left) and detail of shed in the background of photo on the left (right)*

Figure 4.20 show two privies located south of Clydesdale house. The privy in the forefront on the right of *Figure 4.20* is a basic square timber framed structure clad in asbestos cement sheet with concrete flooring and a corrugated iron roof. It is in a fair physical condition. To the left of *Figure 4.20* is a close up north-west view of the privy shown in the background of the image on the right. This privy appears to be a more modern rectangular brick structure with a wooden door and a corrugated iron roof.

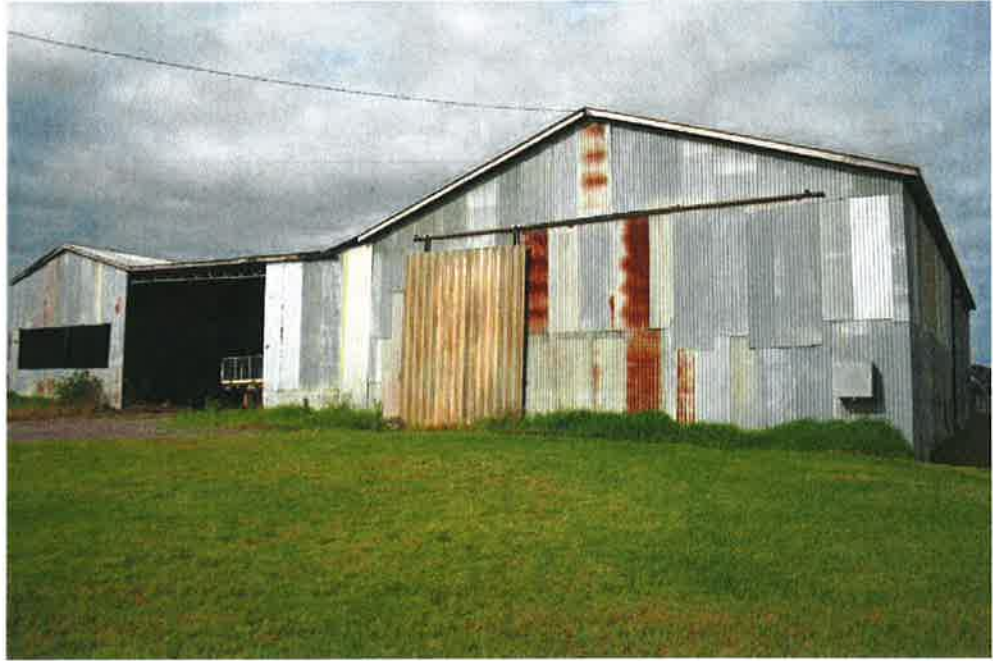
Figure 4.21 South-west view of modern shed located south of Clydesdale house and adjacent to barn

This shed appears to be a modern rectangular structure clad entirely in corrugated iron and currently used for storage (*Figure 4.21*).

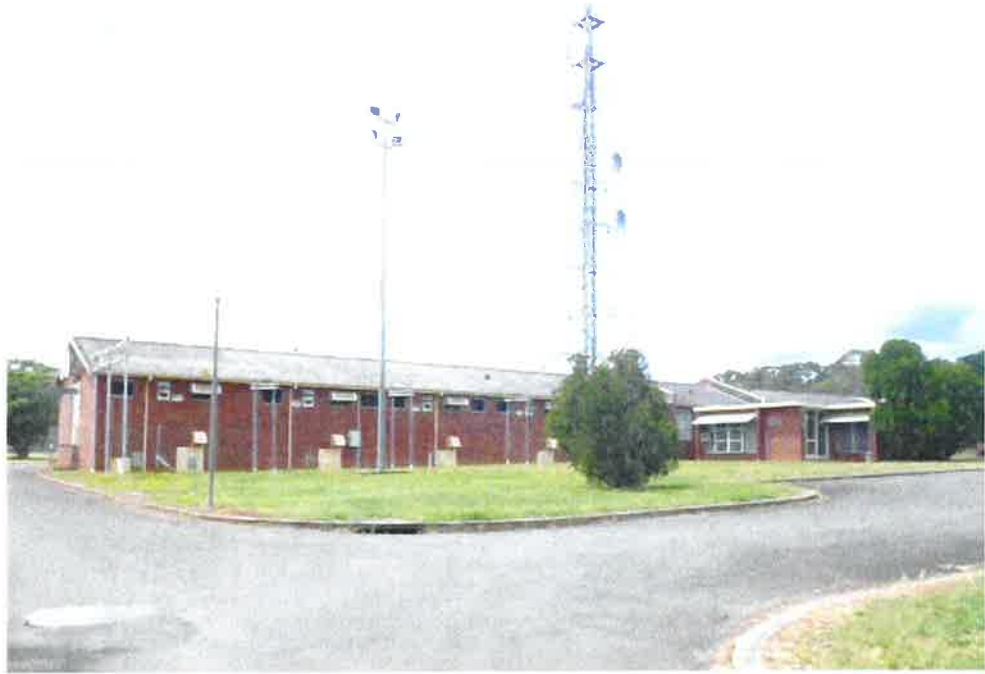
Figure 4.22 East facing photograph of brick buildings within Llandilo including antenna.

One heritage item is listed on Stony Creek Road that is the former Llandilo International Transmitting Station (*Figure 4.22*). The station is situated approximately 800 metres from Stony Creek Road within an undeveloped, heavily vegetated area. The main compound is situated at the end of a private road; within it are a series of brick buildings laid out in a cross. Unfortunately, access to this facility was restricted so a detailed survey was not possible.

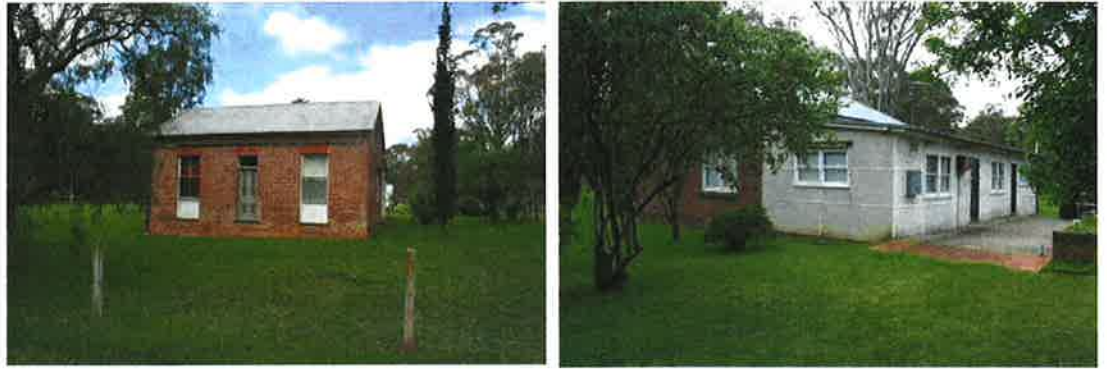
Figure 4.24 *View looking south (left) and the modern alterations to the house from a north-easterly direction (right)*

The survey noted later alterations on the eastern façade of the house that also appear in the photo of the property provided in the NSW Heritage Register (see the image on the right of Figure 4.24).

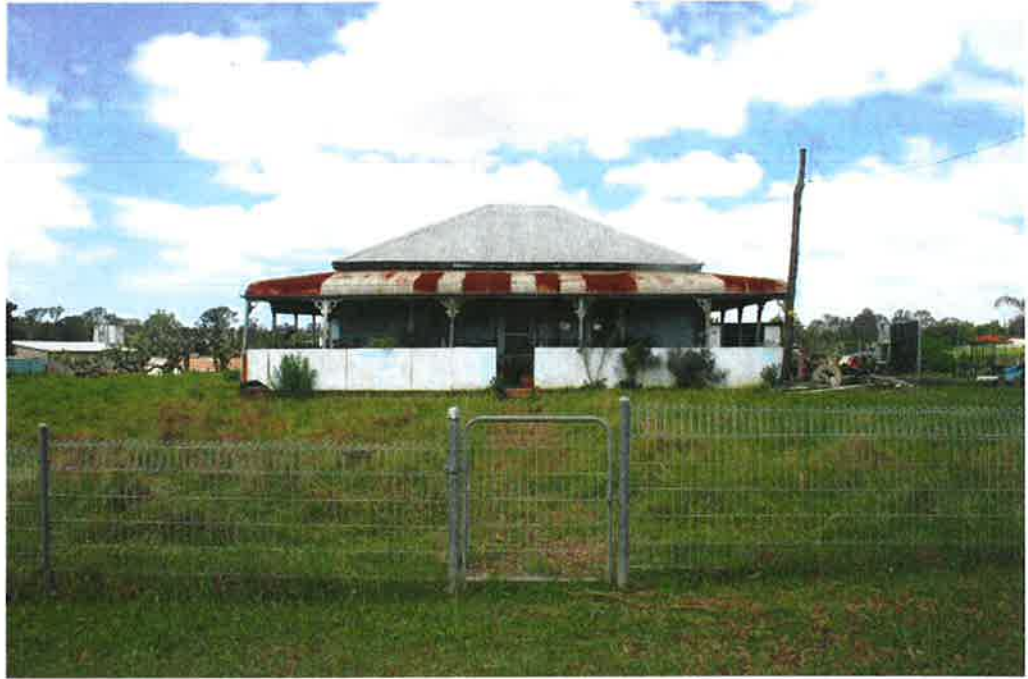
Figure 4.25 View of front facade of 142 Clifton Road looking south

An asbestos clad rear extension to the house was identified during the field survey (Figures 4.25 and 4.26). ERM's survey indicated that there are no other buildings of its type present on Clifton Road, or in the study area.

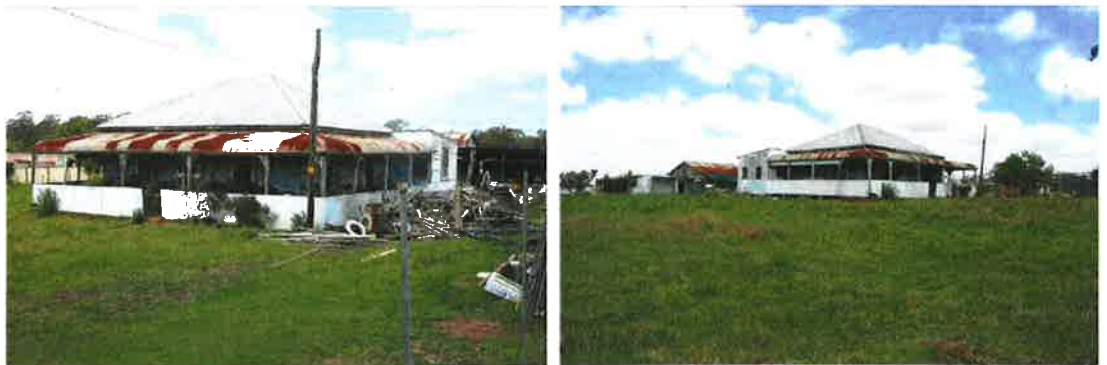
Figure 4.26 View of north and west facades of house looking south east (left) and view of north and east facades of house and rear shed looking south-west (right)

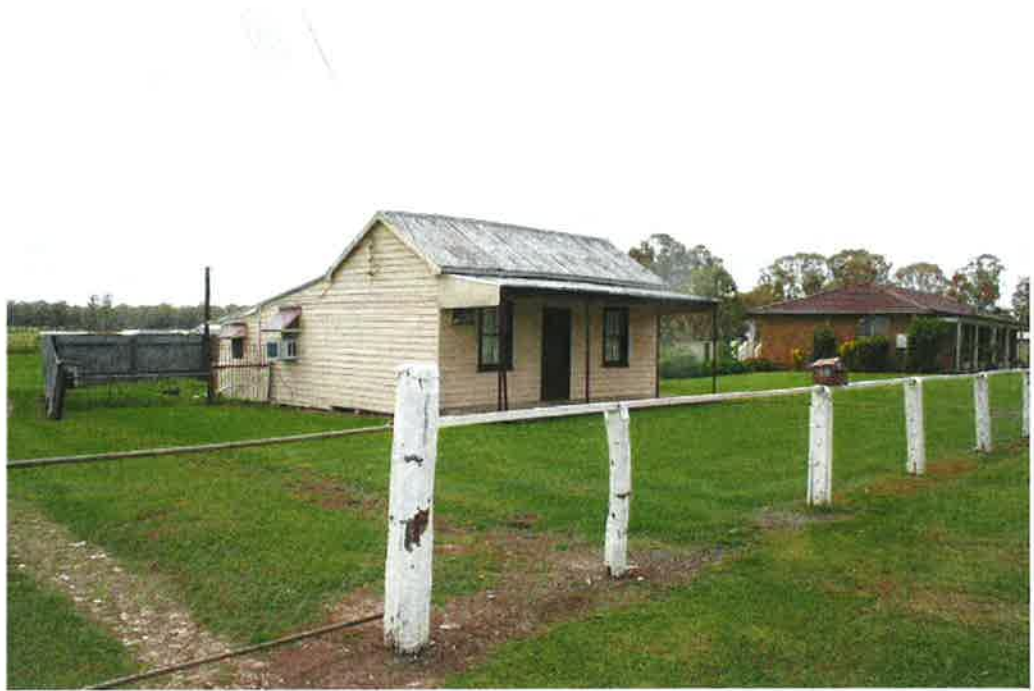
Figure 4.27 View of 37 Vine Street West looking north-east

37 Vine Street West is a small rectangular weatherboard clad cottage with a corrugated iron roof, double hung windows, later verandah on metal posts and rear skillion addition (see *Figures 4.27 and 4.28*).

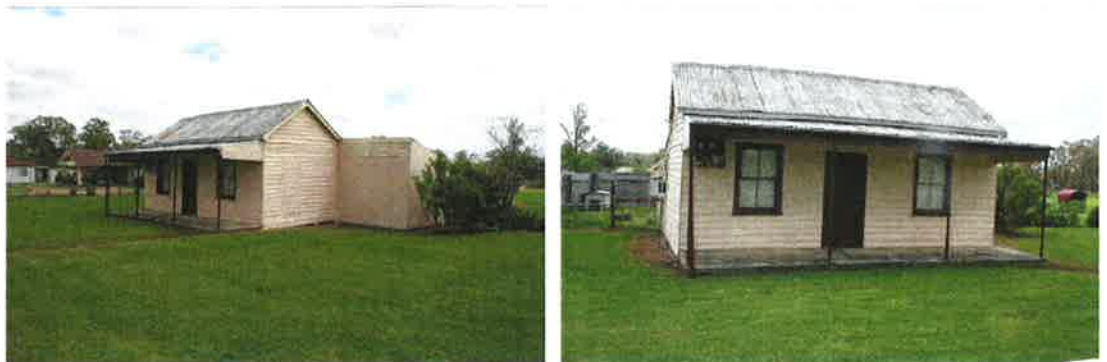
Figure 4.28 Vine Street West looking north-west (left) and north (right)

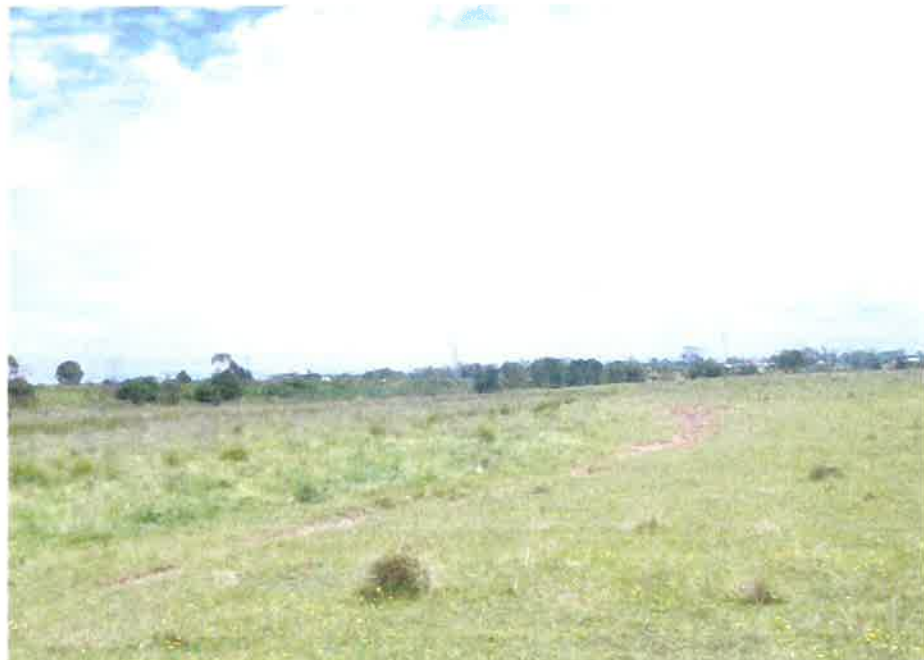
Located on the eastern side of Richmond Road, adjacent to the entrance to Clydesdale House, the NSW Heritage Database lists the site of the former St. Phillips Cemetery and its associated graveyard (see *Figure 4.29*). This site was located during ERM's survey, however no above ground remains are present therefore a precise description is not possible without subsurface investigation.

Figure 4.29 *North-west facing photograph of the St. Phillips Cemetery site, Richmond Road.*

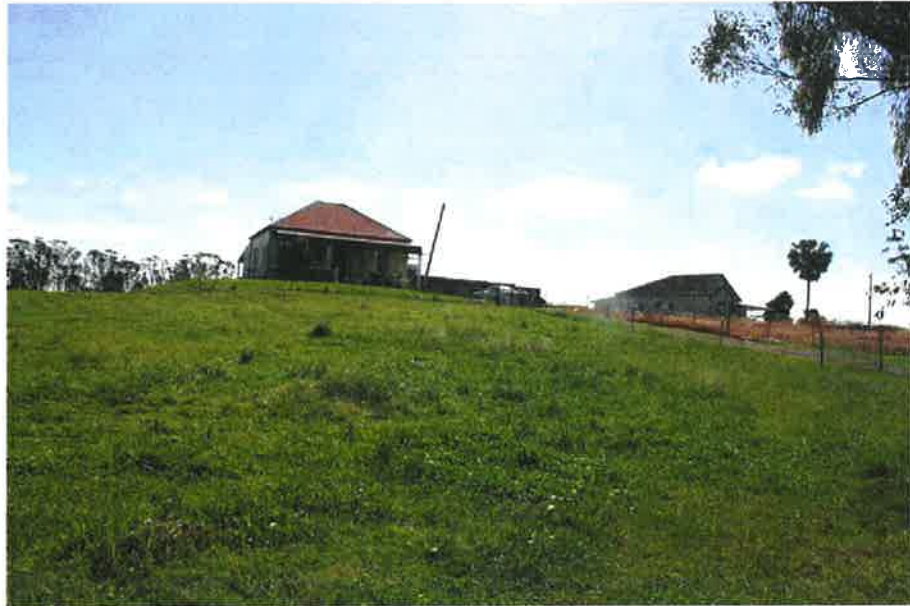
A single storey country cottage with hipped pyramidal roof in galvanised iron and bullnosed front verandah (now filled in). The house occupied a prominent elevated site. Located on the old main road to Richmond this house survives from the mid-to late 19th century (see *Figures 4.30 and 4.31*).

Figure 4.30 North facing photograph of Cottage at 1082 Richmond Road.

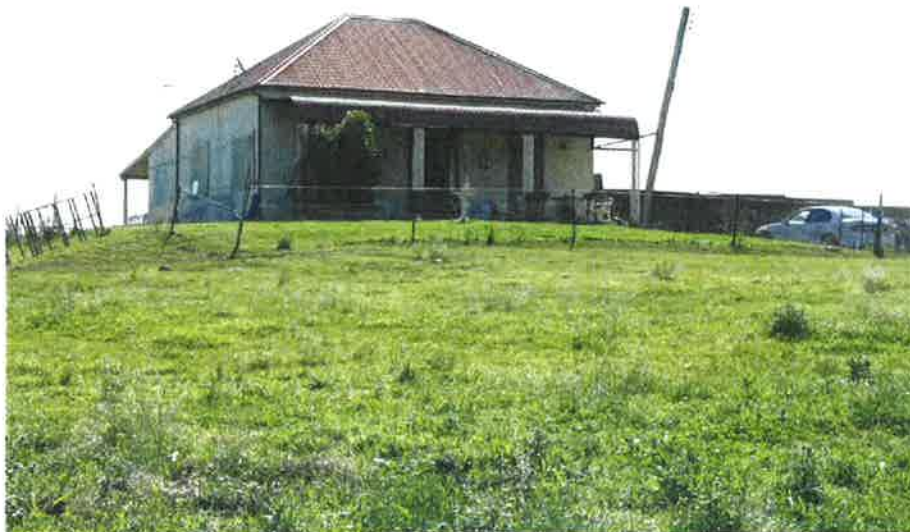
Figure 4.31 North facing photograph of 1082 Richmond Road (Close-up)

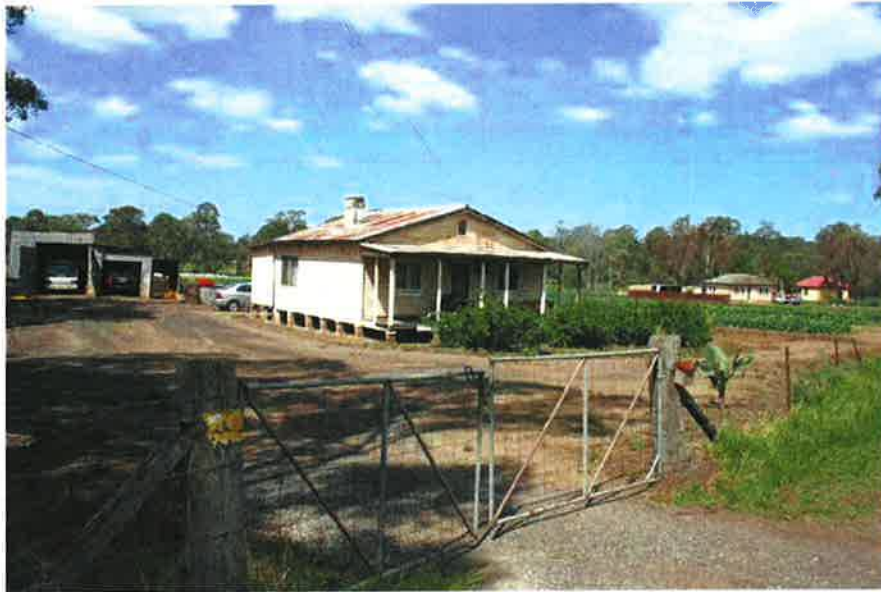
Figure 4.32 View of 1069 Richmond Road looking south-east

1069 Richmond Road is a small rectangular weatherboard clad cottage with a corrugated iron roof, double hung windows, a verandah on timber posts and a brick chimney on its northern elevation (*Figures 4.32 and 4.33*).

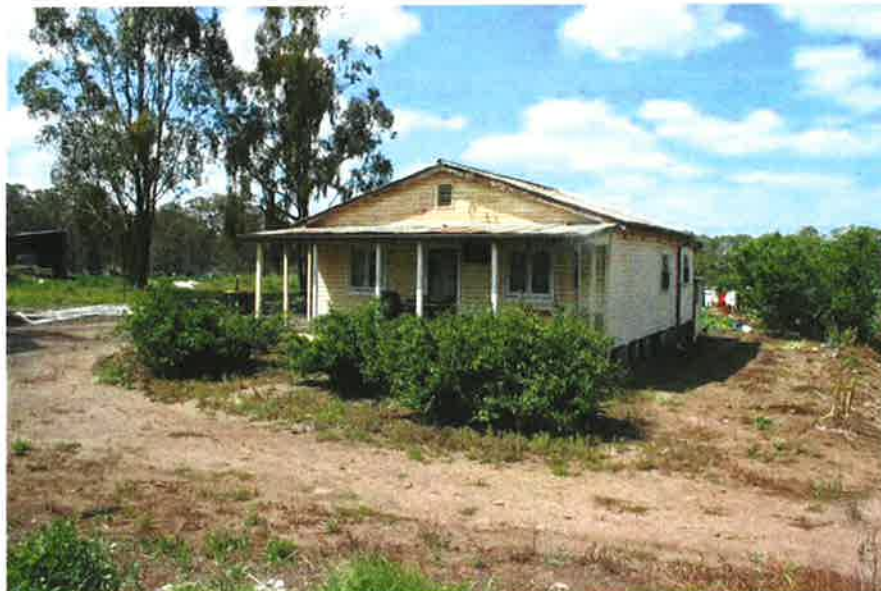
Figure 4.33 View of 1069 Richmond Road looking east

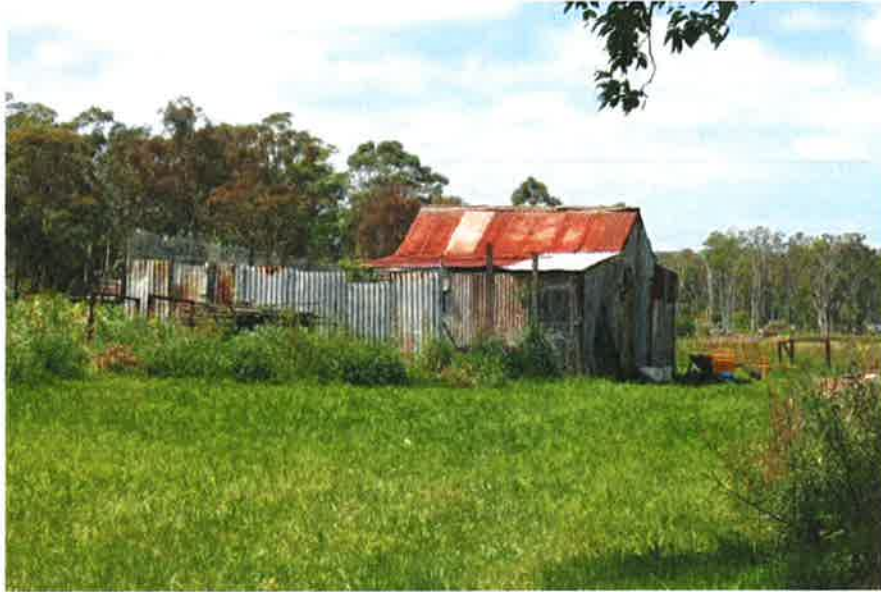
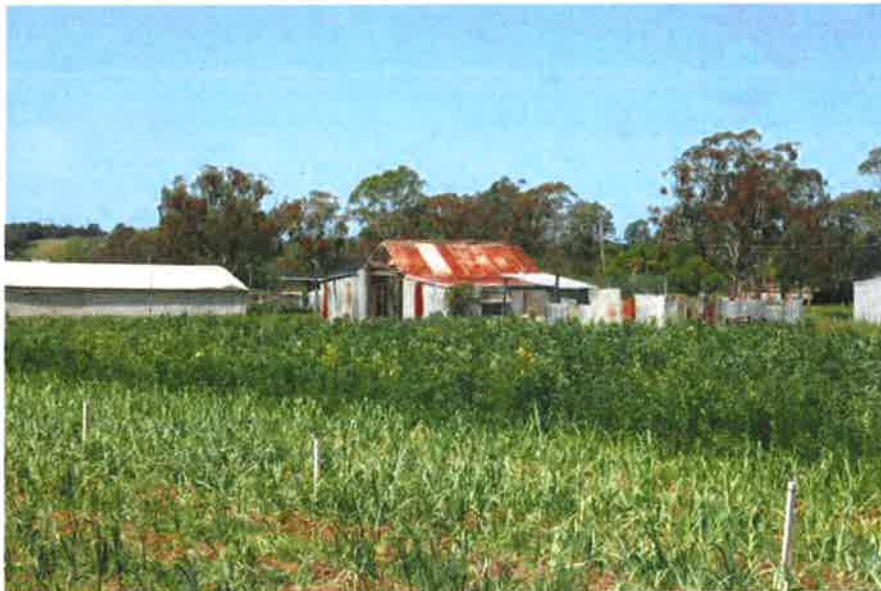
Figure 4.34 Slab cottage between Grange and Richmond

Figure 4.35 Slab cottage between Grange and Richmond

This item is listed in the heritage register as an item of local significance. No statement of significance is contained in this listing. This is a small slab cottage now being used a shed by market gardeners. During the field survey, it was noted that this slab cottage is in extremely poor condition, demonstrating little of its original integrity (see *Figures 4.34 and 4.35*). The structure was comprised of an internal wooden structure with galvanised iron sheets covering the walls and roof.

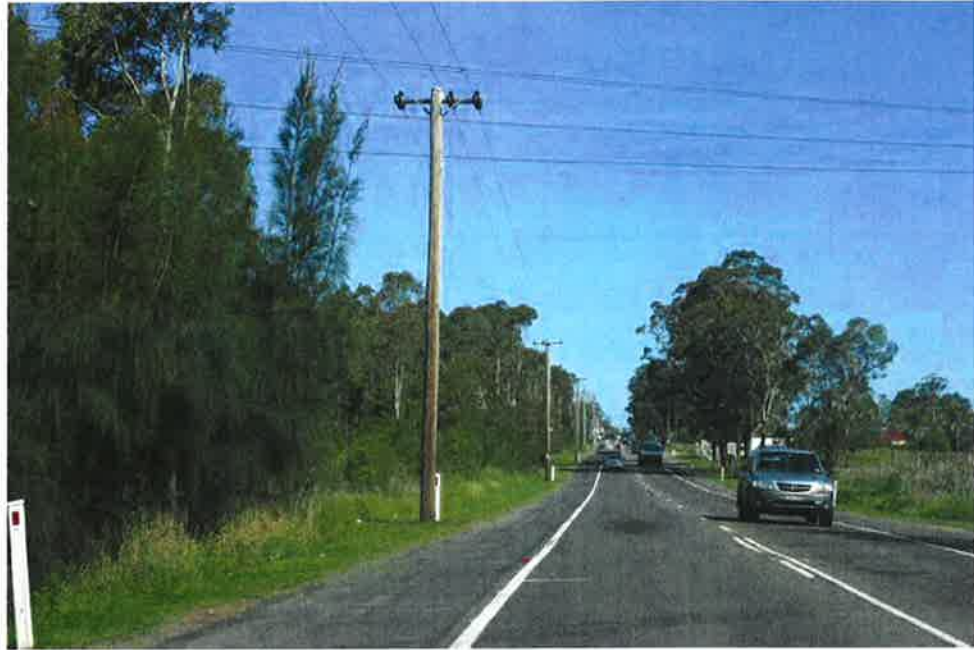
Figure 4.36 Richmond Road looking north

Richmond Road is a 23.5 km route linking Blacktown and Richmond. The survey conducted by ERM in October 2011 identified no evidence of historic road alignments in current day views; however the alignment does not appear to have been altered and there is the potential for archaeological deposits to remain under its current bitumen surface (see *Figure 4.36*).
