Marsden Park Precinct

Historic Heritage Assessment

For Winten Property Group

March 2013

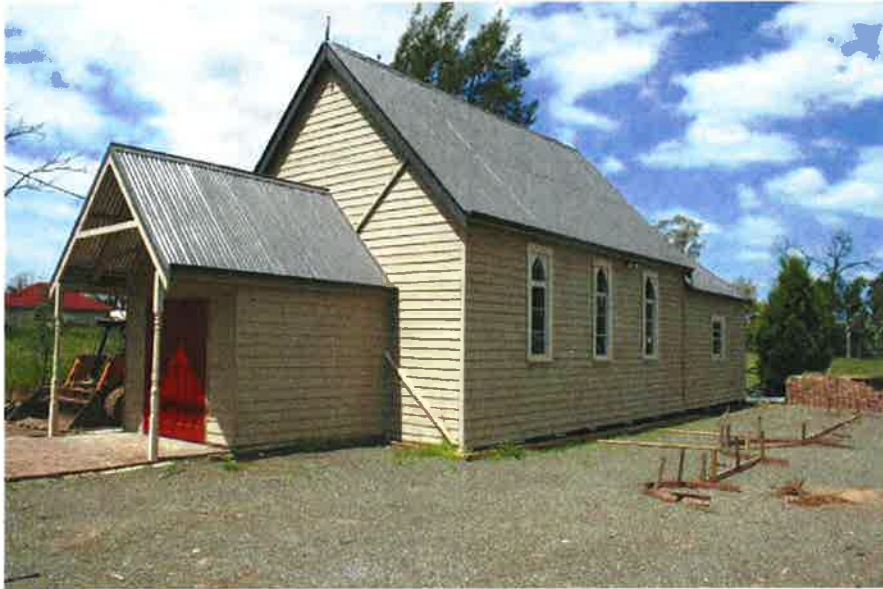
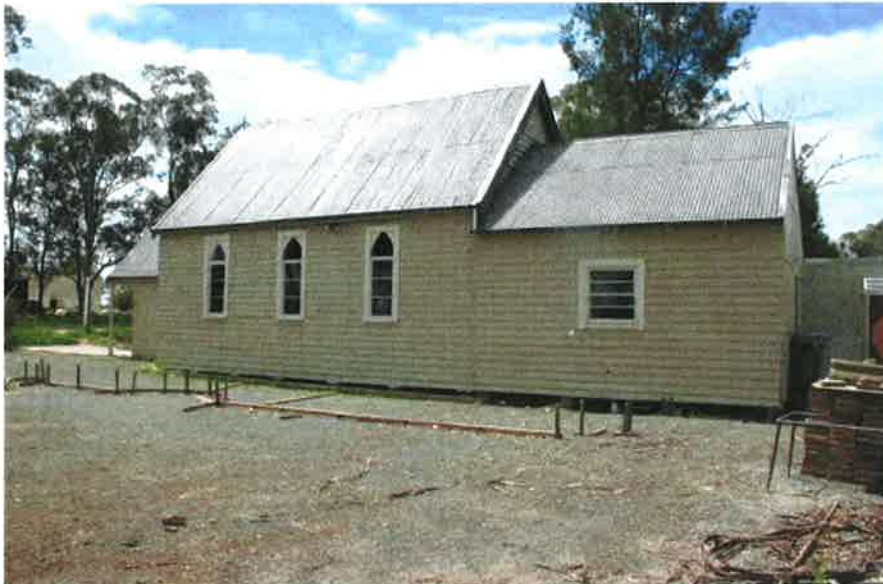
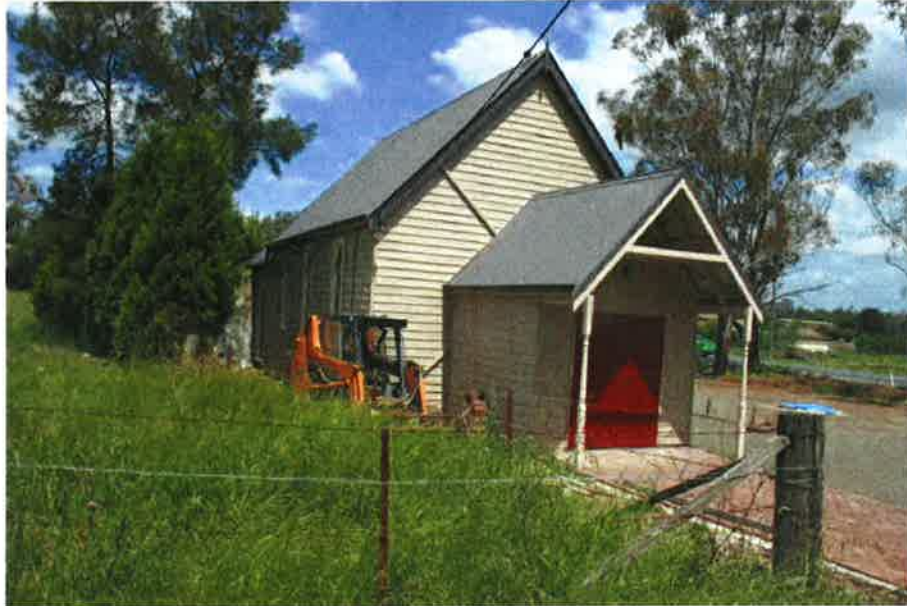
Figure 4.37 Hall, Grange Avenue

Figure 4.38 Hall, Grange Avenue

Figure 4.39 Hall, Grange Avenue

The Grange Avenue Hall was formerly a church (St Andrew's Presbyterian Church). It is a heritage listed item comprised of a simple weatherboard building with gable ended galvanised iron roof, gothic styled side windows, later entrance porch and a timber interior with exposed cross brackets (see 4.37, 4.38 and 4.39). The structure is in excellent physical condition.
