# Turner Road Precinct Landscape Visual Assessment

Growth Centres Commission

March 2007

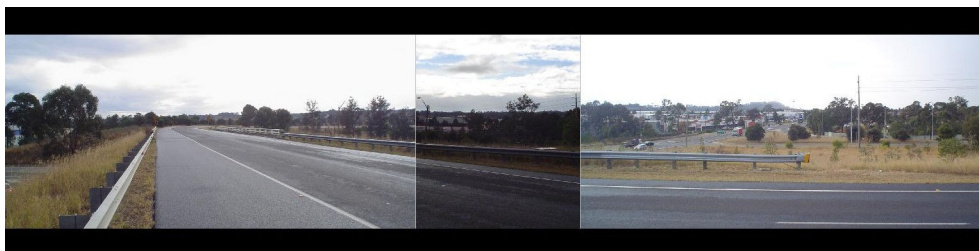
Image 1.4.2 View 1: Narellan Road overpass on Camden Bypass (1) to the Scenic Hills & the Turner Road Precinct.

The Narellan Road overpass provides the first views to the Scenic Hills and the Turner Road Precinct from the Camden Bypass. It is an elevated location that easily depicts the interaction of the commercial section of Narellan Business Centre, with the Turner Road Precinct and Scenic Hills in the background as seen in image 1.4.2.

Only the small land holdings along Turner Road can be easier seen within the study site.

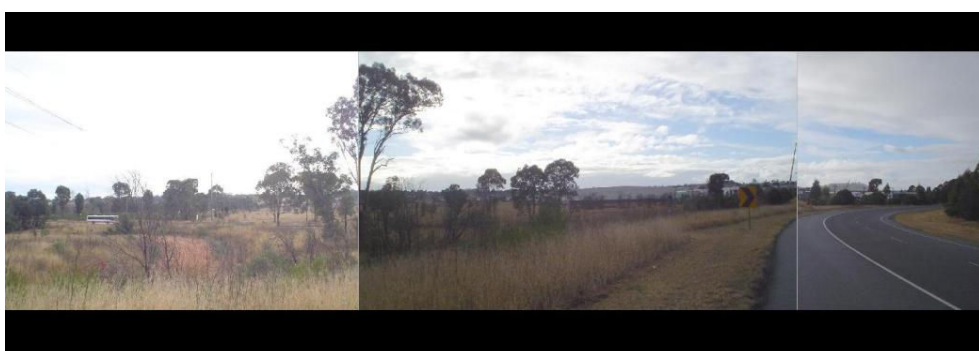
Image 1.4.3 View 2: Narellan Road overpass on Camden Bypass(2) to the Scenic Hills & the Turner Road Precinct.

This location provides views to the Turner Road Precinct and Scenic Hills over the Smeaton Grange industrial site. The factory structures provide contrast and partly block the view to the Precinct and the Scenic Hills. The major ridgeline can still be defined as seen in image 1.4.3.

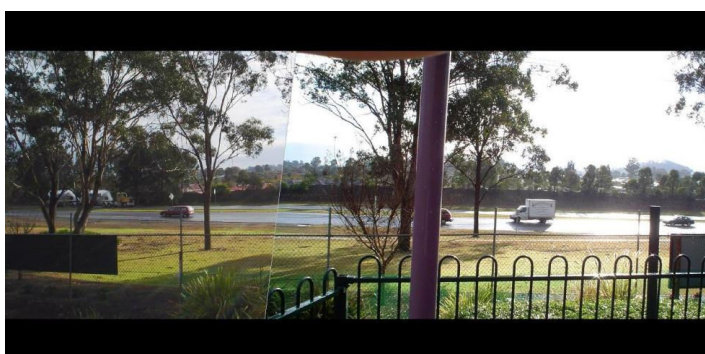
Image 1.4.4 View 3: Cnr of Narellan Road & Mount Annan Road ( Garden Centre) to the Scenic Hills & the Turner Road Precinct.

This location provides an example of close residential development to the Turner Road Precinct and the Scenic Hills. The prominent sections of the ridge line can be seen. The minor sections of the hills have been hidden by the noise attenuation barriers and associated plantings to the Currans Hill residential development, refer image 1.4.4.

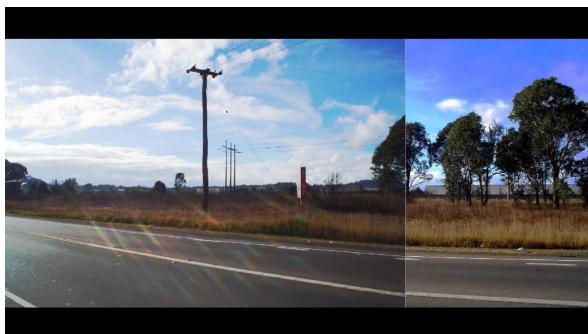
Image 1.4.5 View 4: Cnr Smeaton Grange Road & Camden Valley Way to the Scenic Hills & the Turner Road Precinct.

This Location looks across the future Smeaton Grange land releases. Only the major hill to the Scenic Hills remains dominate, while the ridgeline along Turner road can be easily viewed, as seen in image 1.4.5.

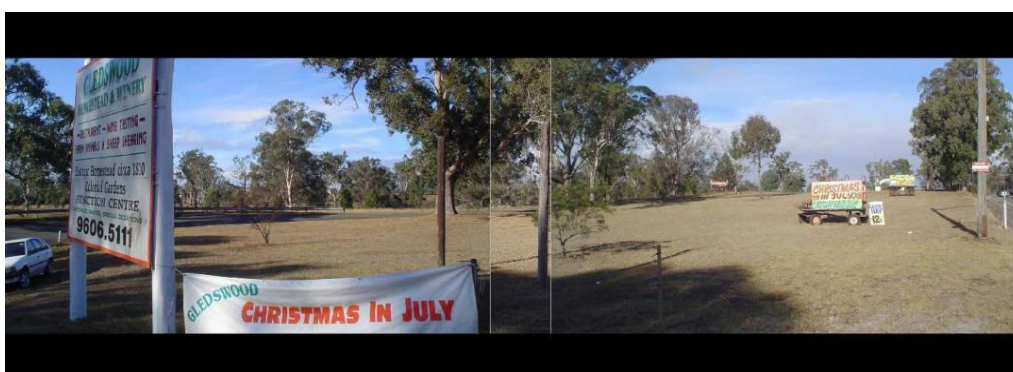
Image 1.4.6 View 5: Cnr Catherine Fields Road & Camden Valley Way to the Scenic Hills & the Turner Road Precinct.

This location has been reviewed to display the lack of views to the Turner Road Precinct and Scenic Hills along Camden Valley Way. The topography and existing trees successfully screen all visual connections to the Turner Road Precinct Scenic Hills, refer image 1.4.6.

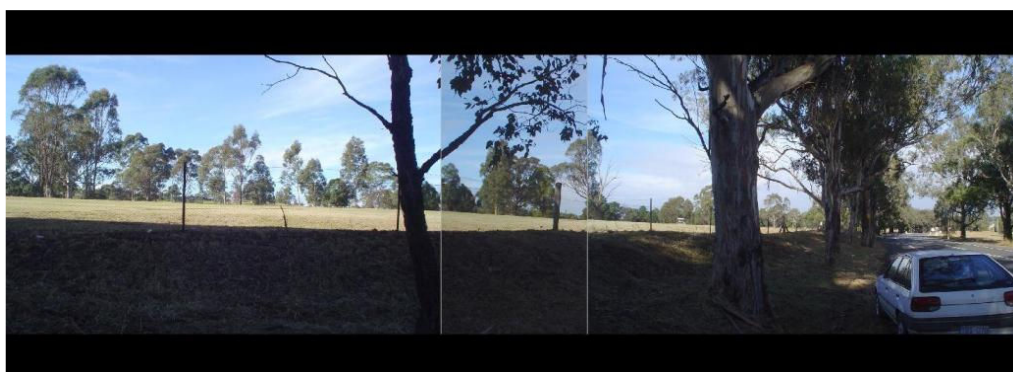
Image 1.4.7 View 6: Cnr Springfield Road & Camden Valley Way to the Scenic Hills & the Turner Road Precinct.

This location is viewing onto the NSW Rugby Leagues Golf Course property. Sections of the Turner Road Precinct within the golf course can be easily seen, however the topography and existing trees screen all visual connections with the Scenic Hills as seen in image 1.4.5.

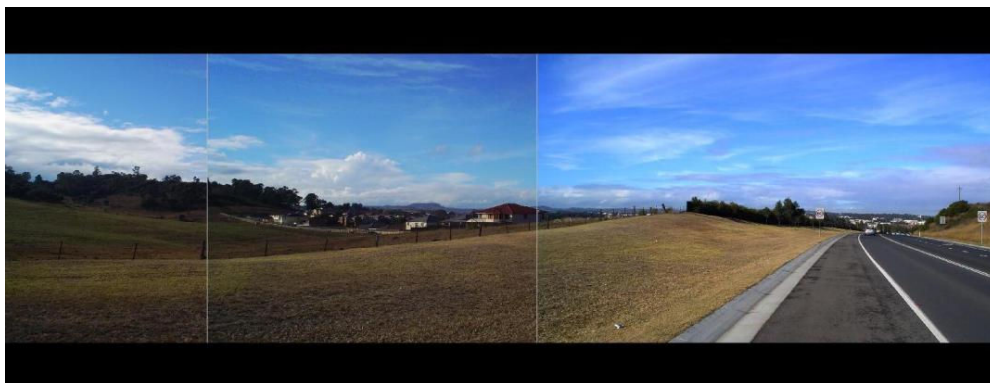
Image 1.4.8 View 7: The Northern Road (1) to the Scenic Hills & the Turner Road Precinct.

This location provides the direct views to the Turner Road Precinct and the Scenic Hills from the Northern Road. The hills appear quite dominate along the horizon despite the houses to the foreground as seen in image 1.4.8.

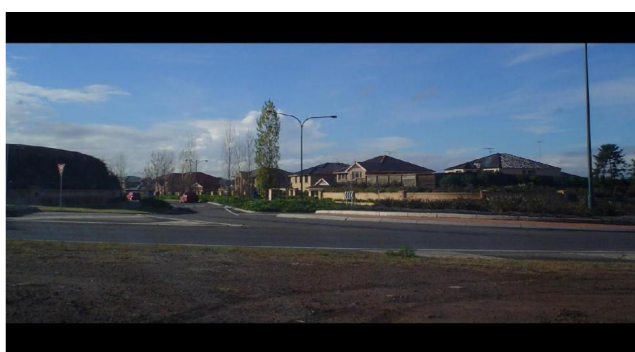
Image 1.4.9 View 8: Cnr of the Northern Road & Hillside Drive to the Scenic Hills & the Turner Road Precinct.

There is no visual connection to the Turner Road Precinct and the Scenic Hills from this section of The Northern Road due to topography and the residential structures screening the view. Refer image 1.4.9.

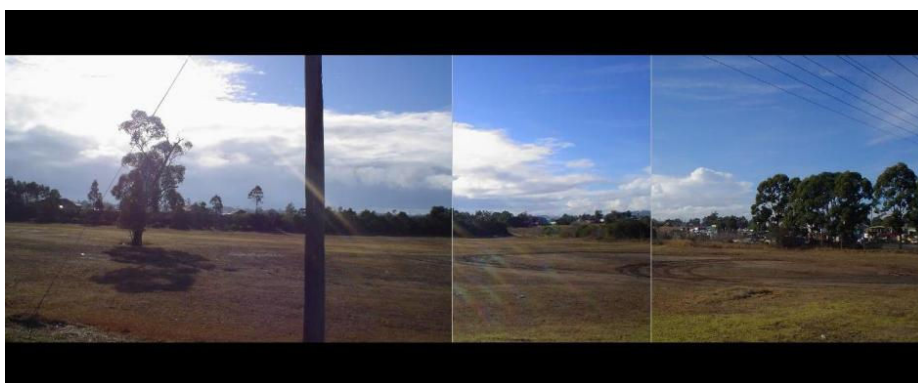
Image 1.4.10 View 9: The Northern Road (2) to the Scenic Hills & the Turner Road Precinct.

This section of The Northern provides distant views to the Turner Road Precinct and the Scenic Hills. The major ridge is prominent along the horizon while the lower sections of the ridge are partly screened by the fore and middle ground as seen in image 1.4.10.

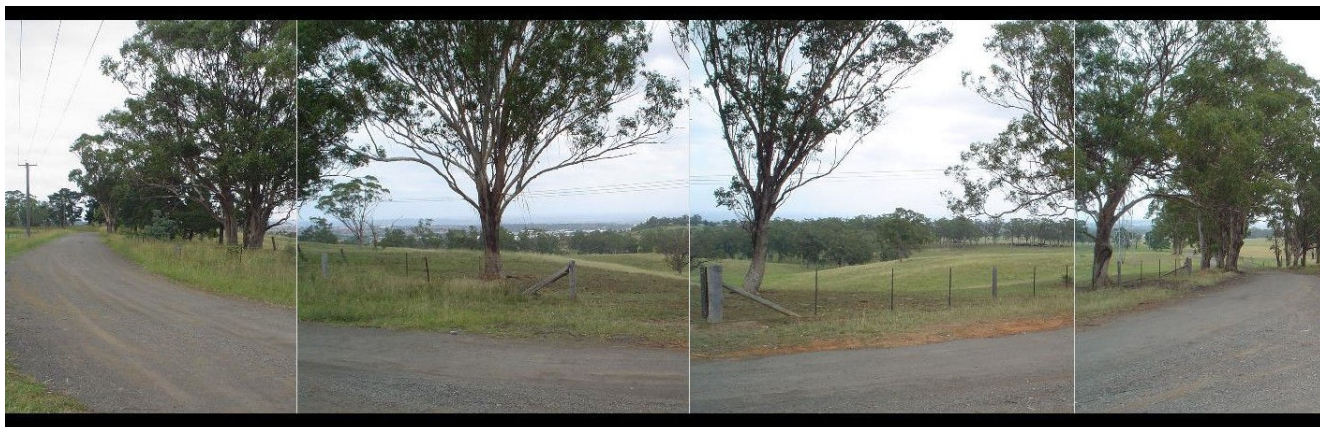
Image 4.1.1 Typical View of Unit 1

The concealed nature of the majority of this unit would allow it to absorb a low to medium level of development; with low levels of development required to accommodate the existing stand of vegetation to the base of the gully. Residential development suits this location, allowing smaller building footprints that would suit the steeper slopes and minimise visual impact.

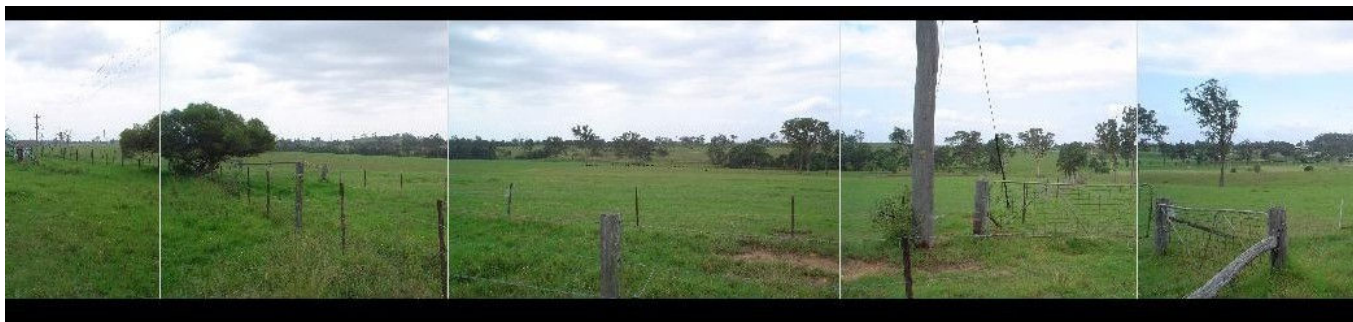
Image 4.2.1 Panoramic View of Unit 2 from the Existing Dairy

The concealed nature of the majority of this unit would allow it to absorb a reasonable level of development. Residential development suits this location due to the topography of the unit and its proximity to the rest of the precinct and the existing surrounding features of St Gregory's College & the Scenic Hills.

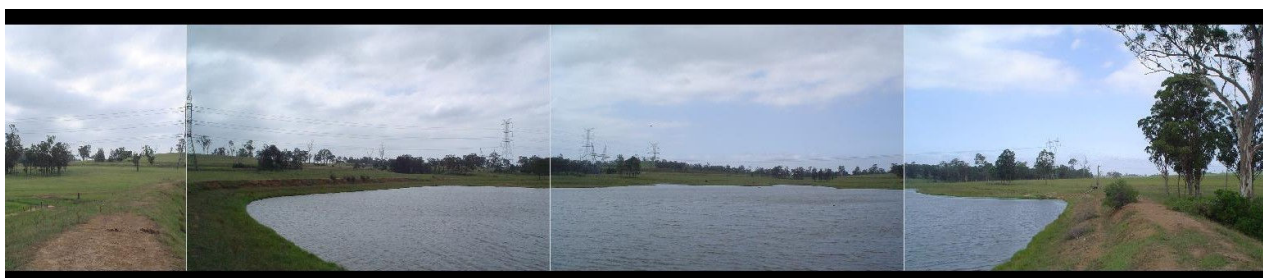
Image 4.3.1 Typical View of the Unit 3

This unit should retain its character, due to the interconnection of this LCU with the South Creek landscape and landscape of the Scenic Hills. Steps could be taken to create functional communal parklands while ensuring that the ecological elements and visual open space are retained and enhanced.

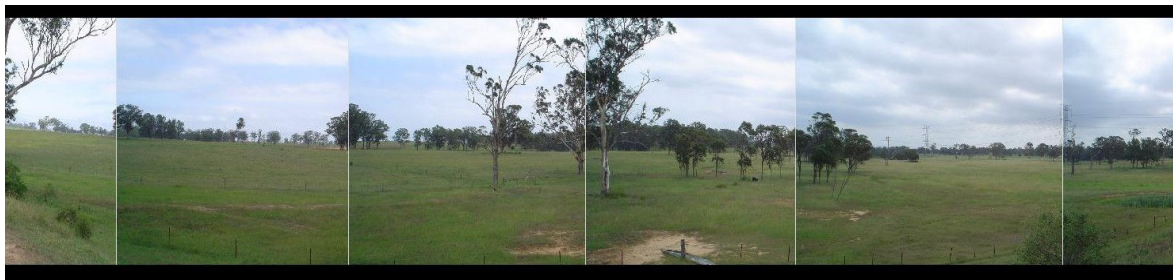
Image 4.4.1 Typical View of Unit 4

This unit contains the beginning of the South Creek. It is predominately low lying with greater variation to the south west of the site, which is similar in context, topography and form to LCU 5. Scattered trees are found throughout the unit with increased clusters to the centre of the unit. The lower lying sections of LCU 4 are part of the broader visual view line to the Scenic Hills and are part of the South Creek. It connects to the open space dedicated in LCU 3 and LCU 8.

LCU 4 displays areas suitable for both development potential and protection of existing open space. It has been categorised suitable for LR- low residential, with the retention and conservation of existing resources.

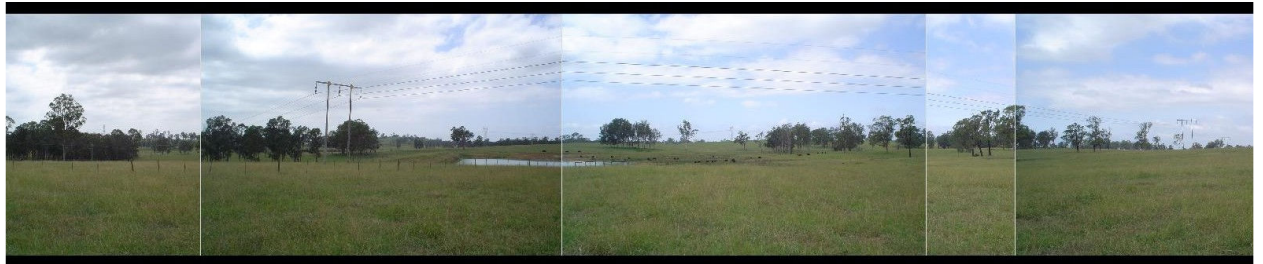
Image 4.5.1 Typical View of Unit 5

This unit is a gully found between two dominate ridges found to the centre of the site. It is pastoral land that contains small dams and scatted clumps of remnant trees. This unit is an important section for the Upper South Creek catchment area.

This LCU has been determined to be suited to a medium development level. It demonstrates the assessments end result of a residential development mix set into and amongst natural land features which should be preserved as open spaces.

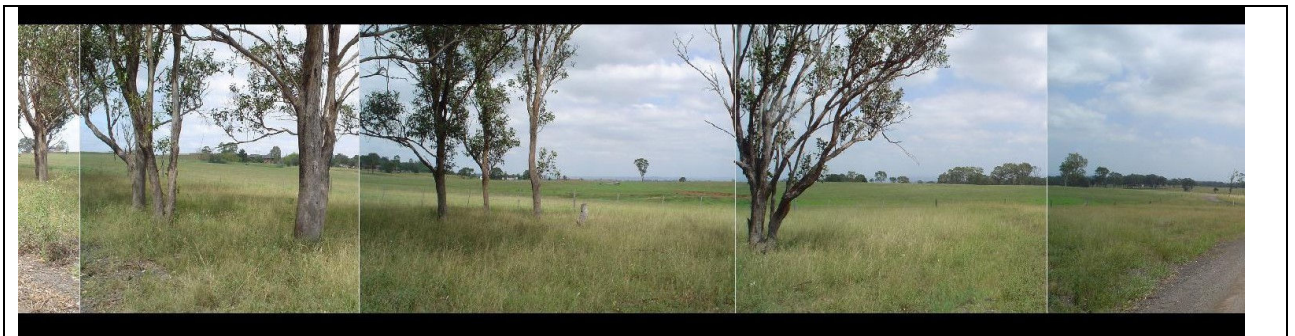
Image 4.6.1 Typical View of unit six

This unit consists of pastoral land and scattered clumps of trees. The land is undulating and contains two landscape features; one is the rodeo arena to the south west of the unit, and the other is the dry stone and timber walling found along Badgally road to the mid east of the unit.

This LCU has been classified suitable for a medium to high level development. Although most of the site is considerably level and suitable for high levels of development, sections in the south and east of the unit have an undulating profile suitable for medium development.

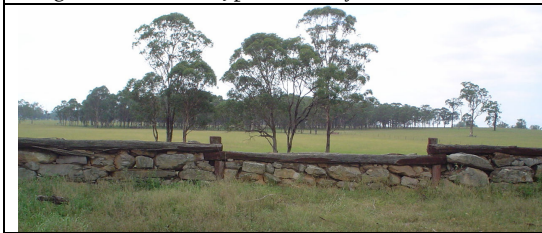
Image 4.6.2 Stone Wall

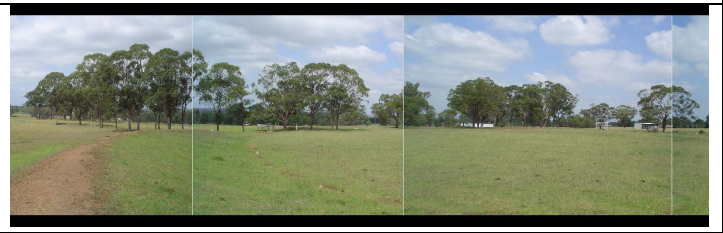
Image 4.6.3 Rodeo Arena & Surrounding Structures.

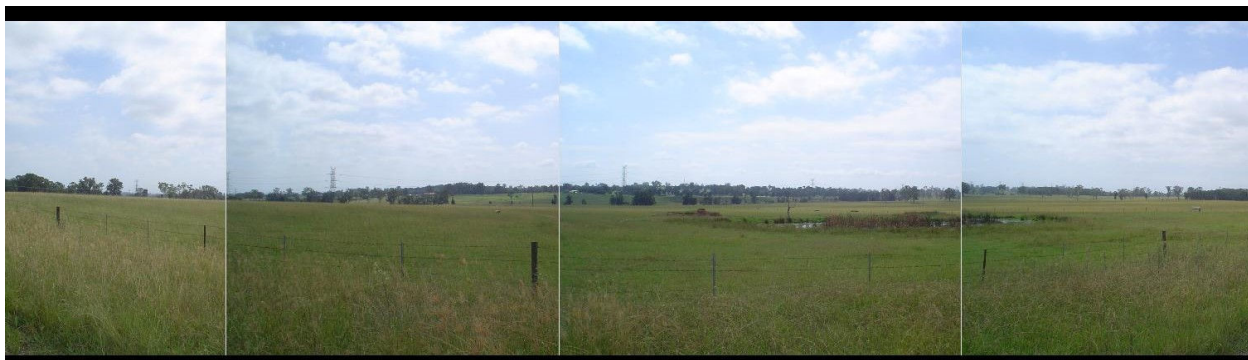
Image 4.7.1 Typical View of unit seven

This LCU is has been classified suitable for high level development. The site is considerably level pastoral lands that are suitable for high levels of development. There is a prominent grove of trees to the east of the unit that should be retained. The unit has a drainage lines to the east of the unit that flows into the South Creek, which will restrict high level development to this section.

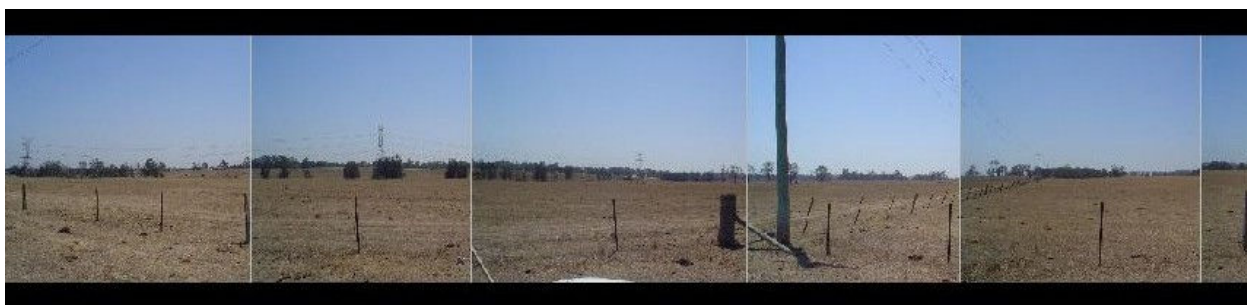
Image 4.8.1 Typical View of unit eight

This LCU has been classified suitable for low to high development due to its exposed nature and the inclusion of the South creek that flows east-west through the centre of the unit, and cannot be developed, while the flatter pastoral sections with the south of the unit are suitable for development. Amelioration measures will be required ensure any development can be integrated into the landscape.

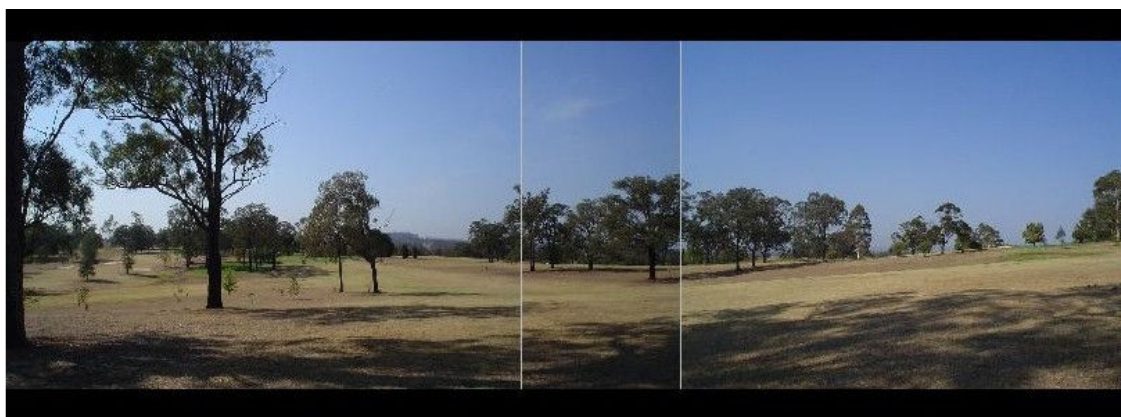
Image 4.9.1 Typical View of unit nine

This LCU is suited for a high level of development due to the sheltered location, the moderate topography of the unit, and the spacing of upper canopy trees throughout the unit.

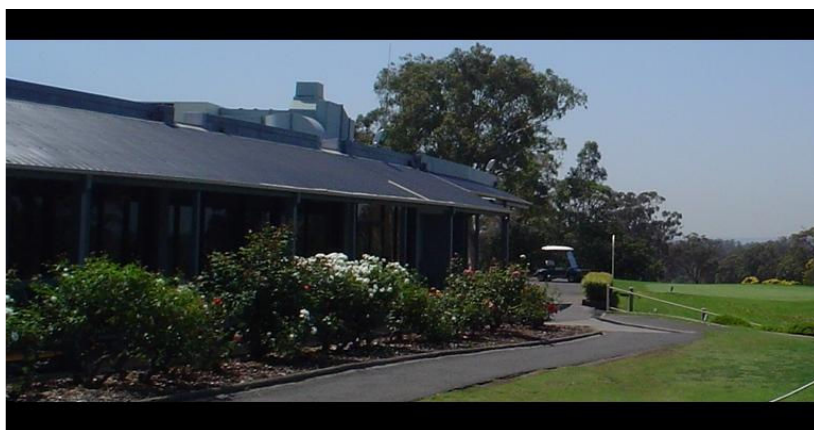
Image 4.10.1 Typical View of unit ten

This LCU is suited for a high level of development due to the gentle topography, existing uses and access throughout the unit.

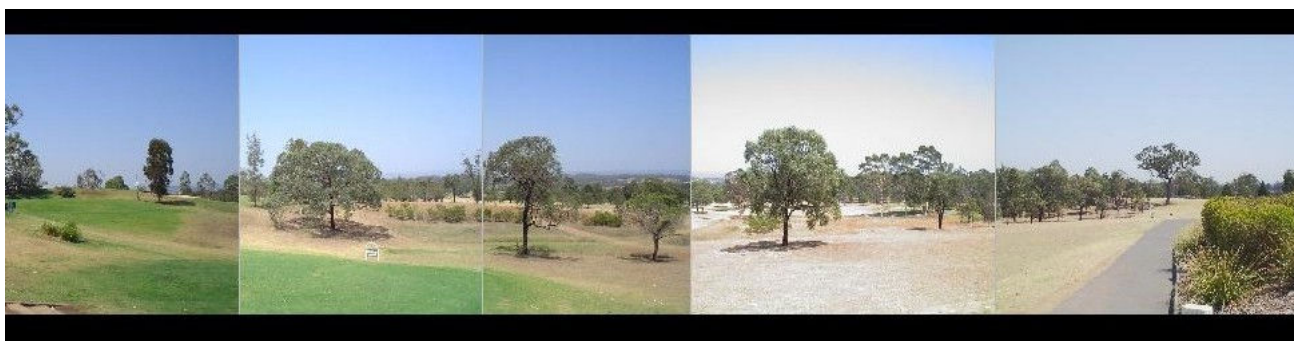
Image 4.11.1 Typical View of unit eleven

This unit consists of a maintained golf course with stands of trees scattered throughout. The unit is bounded by the Camden Valley Way to its west and has the pastoral lands/ South Creek to its south. This part of the golf course is the primary section, with a greater density of plantings and a larger presence of water found throughout. The unit provides an important screen to the rest of the land owned by the golf course.

This LCU is suited for medium development due to its gentle to moderate topography and dispersal of upper and lower canopy trees scattered throughout. This creates an opportunity to integrate development within the unit.

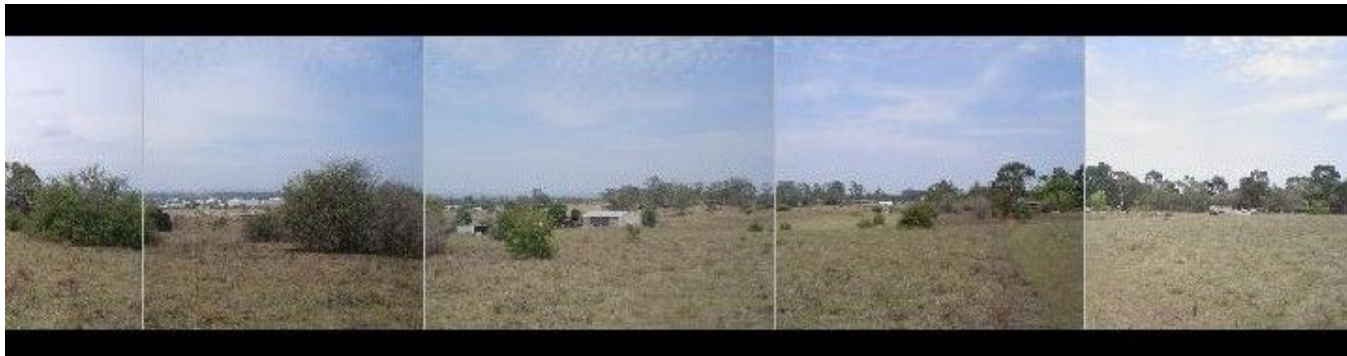
Image 4.12.1 Typical View of unit twelve

This unit consists of existing small rural/residential properties on the hill top with plantings around the dwellings and scattered vegetation throughout the paddocks. There are several small dams found throughout this unit. The unit is bounded by Camden Valley Way and Turner Road. It will also have the Harrington Park Two development bordering it on the western side of the Camden Valley Way.

This LCU is suited for a medium level of development due to its gentle to moderate topography. The diverse range of buildings, structures and plantings found throughout reduce the unit's visual vulnerability, however it is located on a ridge that can be seen from many surrounding suburbs.

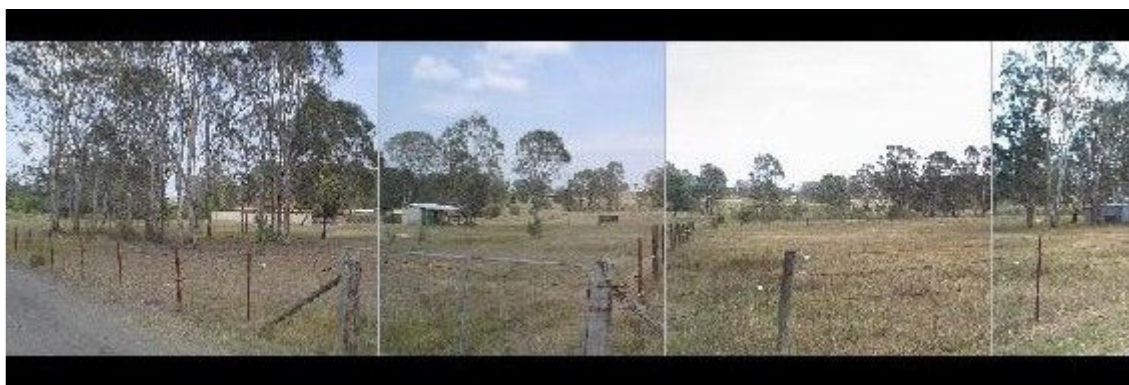
Image 4.13.1 Typical view of unit thirteen

This unit consist of a number of small rural residential dwellings found the gentle slopes of the Turner Road ridge line. The unit contains a wide variety of structures and contains many clusters of trees scattered throughout. The unit also contains an important drainage line for the Kenny Creek catchment.

This LCU is suited for a medium level of development due to the gentle topography of the site, the upper and lower canopy trees, and the variation of structures found throughout the unit.

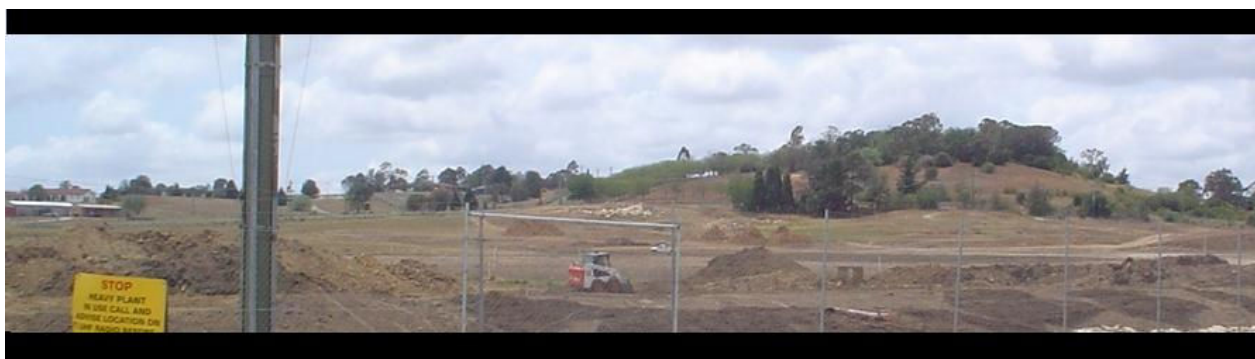
Image 4.14.1 Typical View of unit fourteen

Ecological Vulnerability	Low	The unit consists of dwellings and grazing paddocks. There are introduced plant species found throughout.
Visual Vulnerability	High	The unit is a very prominent hill that can be seen from most of its surrounding suburbs.

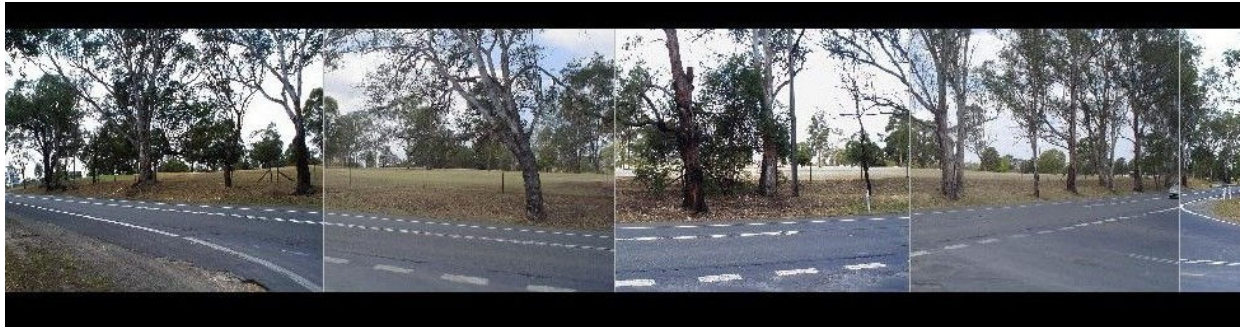
Image 5.1.1 - View shed A, as viewed from the Cnr of Springfield Rd & Camden Valley Way

Road side plantings provide further screening to distant views onto site.

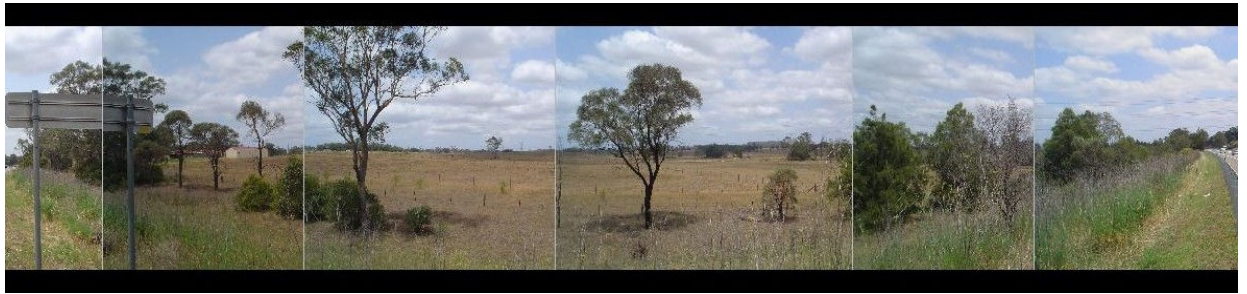
Image 5.2.1 - View shed B, as viewed from Camden Valley Way.
